BLACKBURN, DANIELS, O'BARR STRUCTURAL ENGINEERS

Observation Report

To: Hal Gandy
From: Jack Daniels
Date: 5-11-20
Subject: Alexander City Hall and Police Station Observation

Observation Date: 4-2-20
Site Conditions: Normal

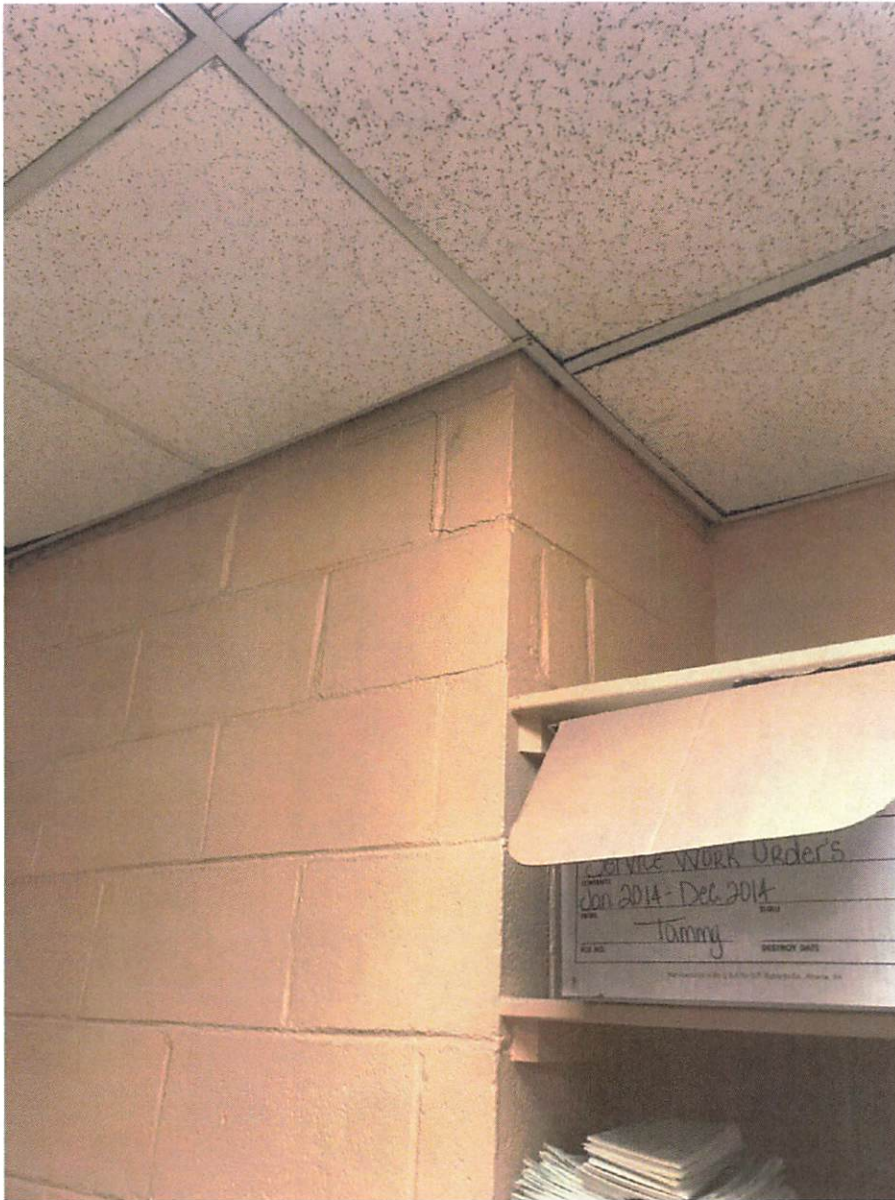
Picture #2. CMU cracks

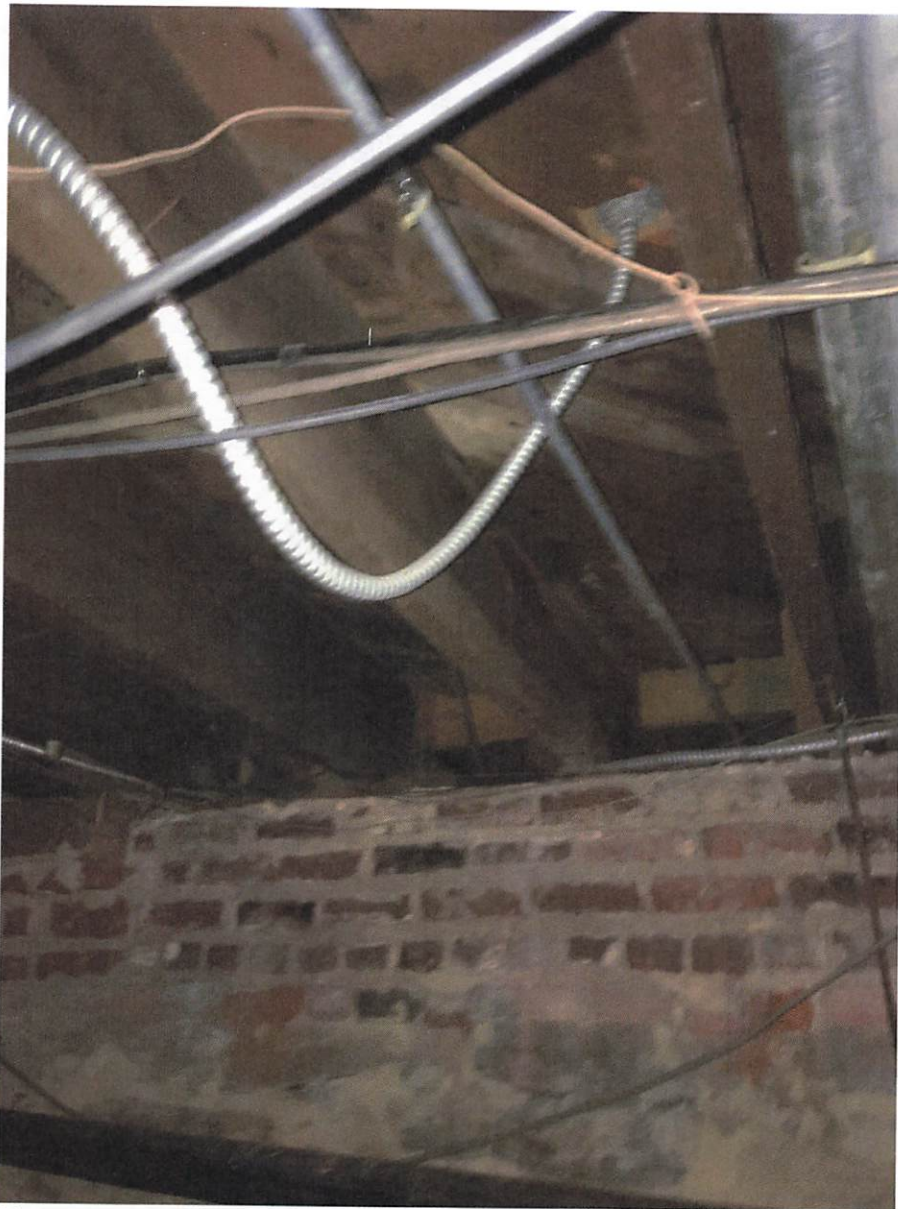
Picture #3. Wood framed floor system

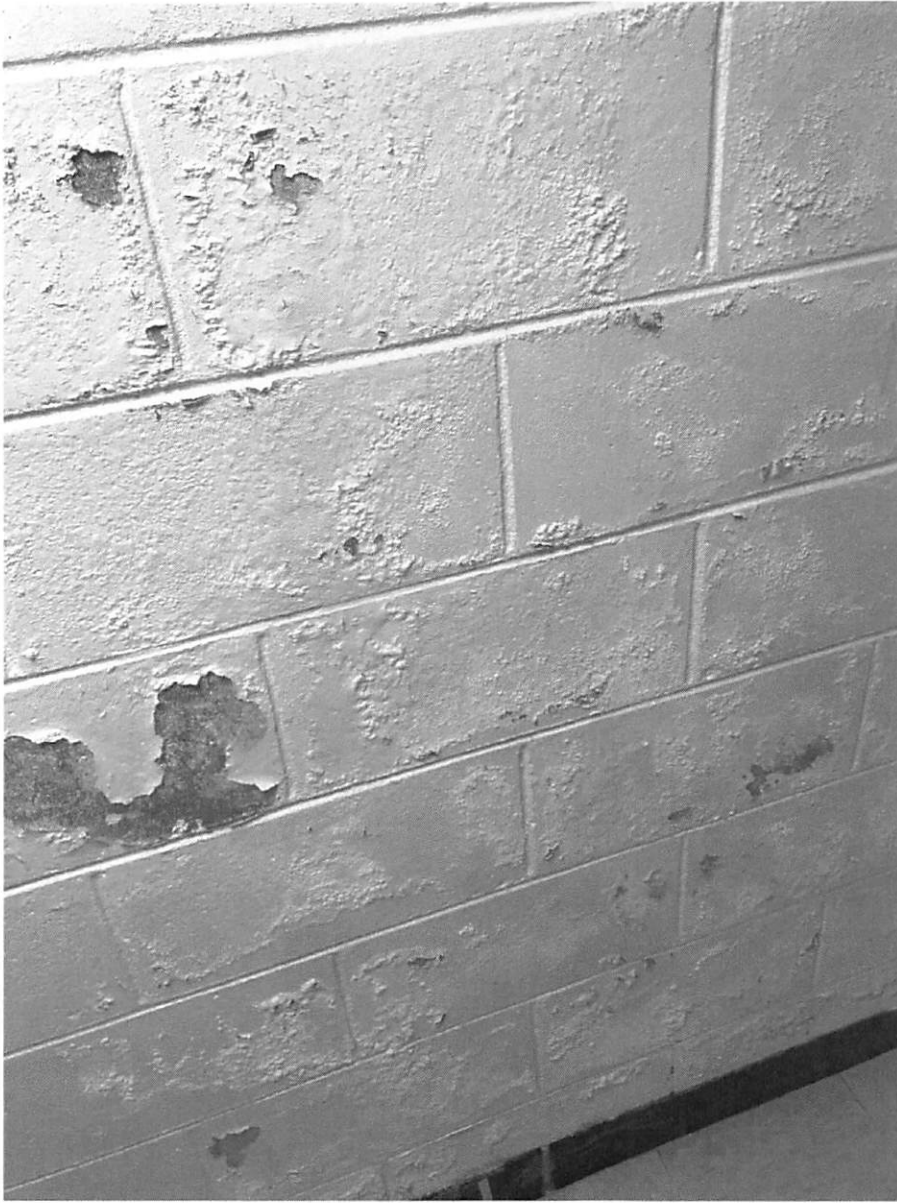
Picture #4. Water intrusion

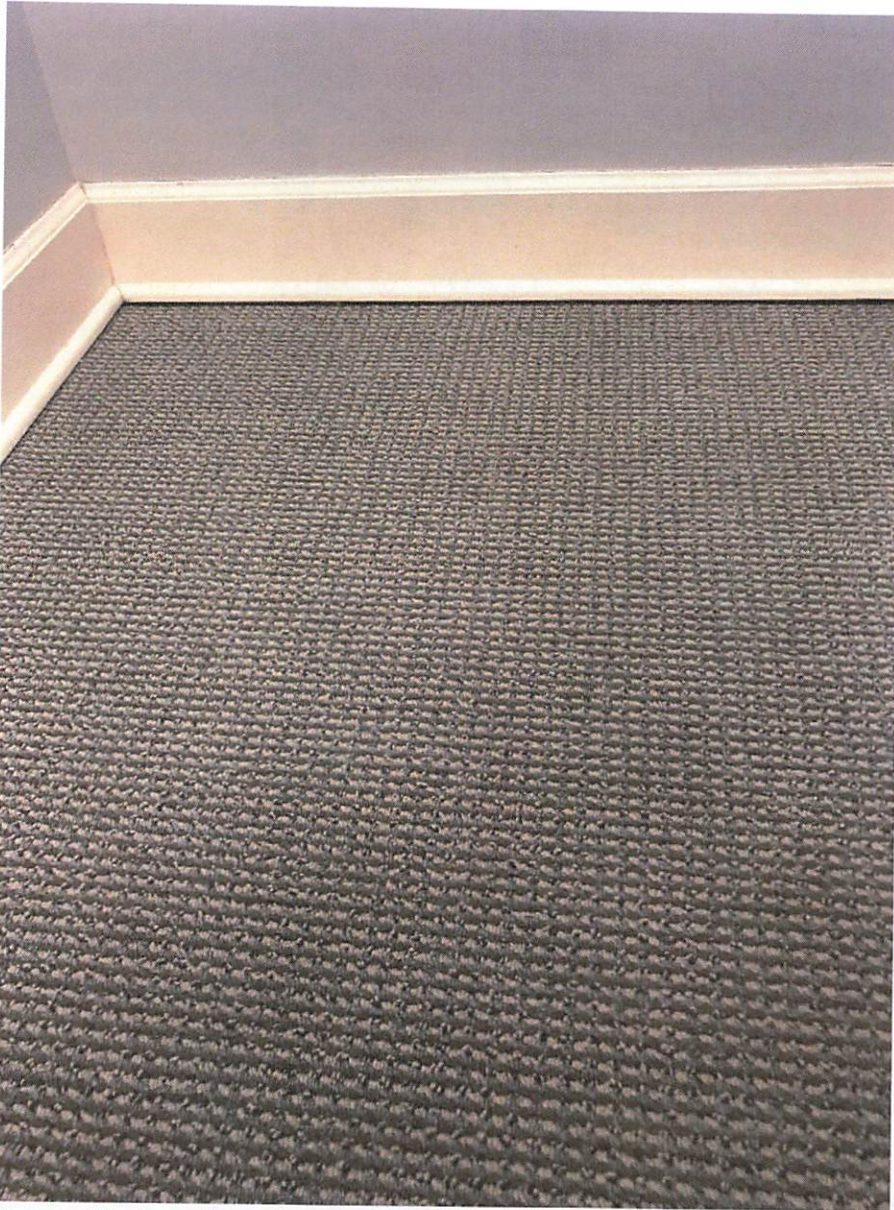
some areas in the older wood framed portion that appears to have sagging floors. These may be seen in picture #5. It is difficult to determine exactly why these floors are sagging but may be due to long term deflections, rot, or water damage. At the rear of the building the exterior finish has been removed from what I was told to be cracking. This may be seen in picture #8. One of the major structural concerns with this building is with the attachment of the precast panels at the front of the building. At the time of the observation near the top corners, the precast panels appear to be pulling away from the building. These may be seen in pictures # 9 thru #11. This is most likely due to a failing connection. I recommend removing the panels that appear to be displaced and try an determine a proper solution once the connections can be viewed.

Picture #5. Are where floor appeared to sag

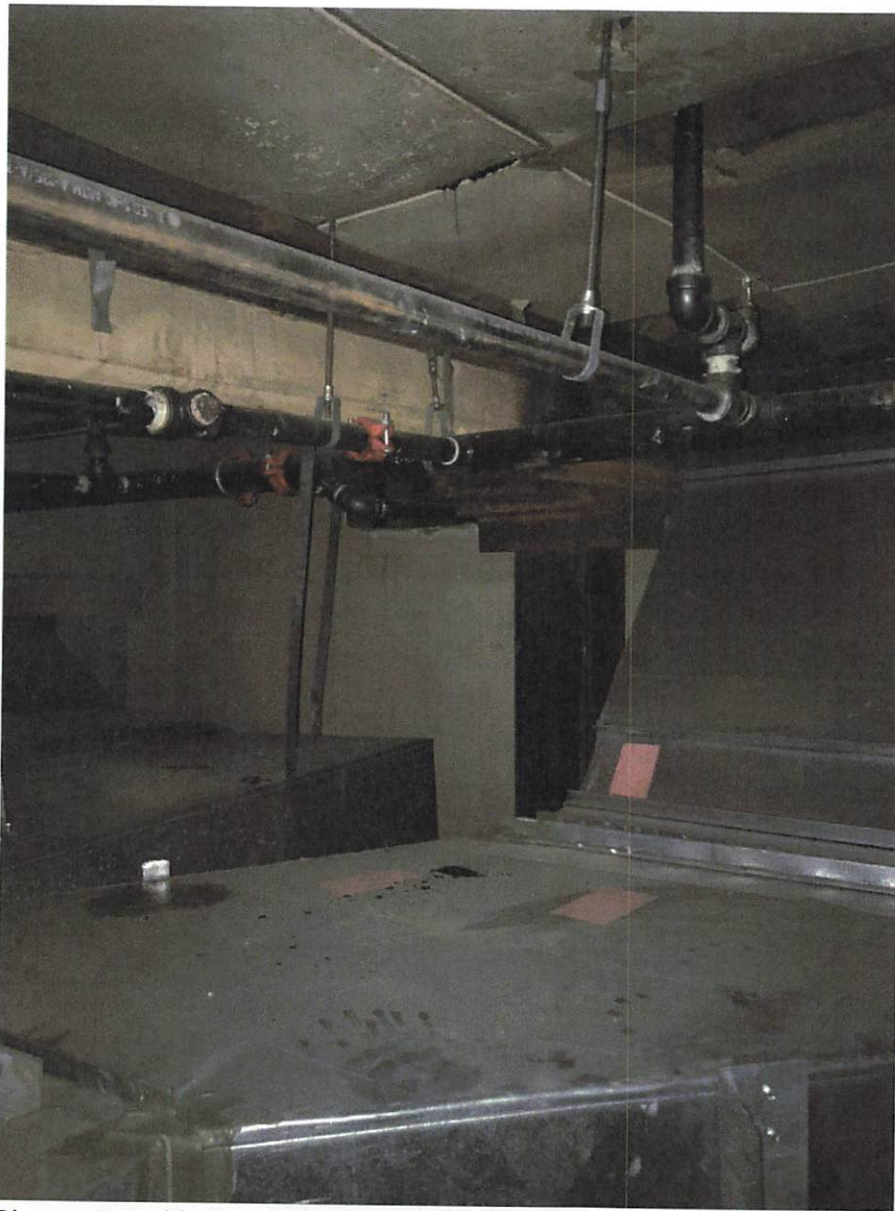
Picture #7. Added steel most likely from an addition

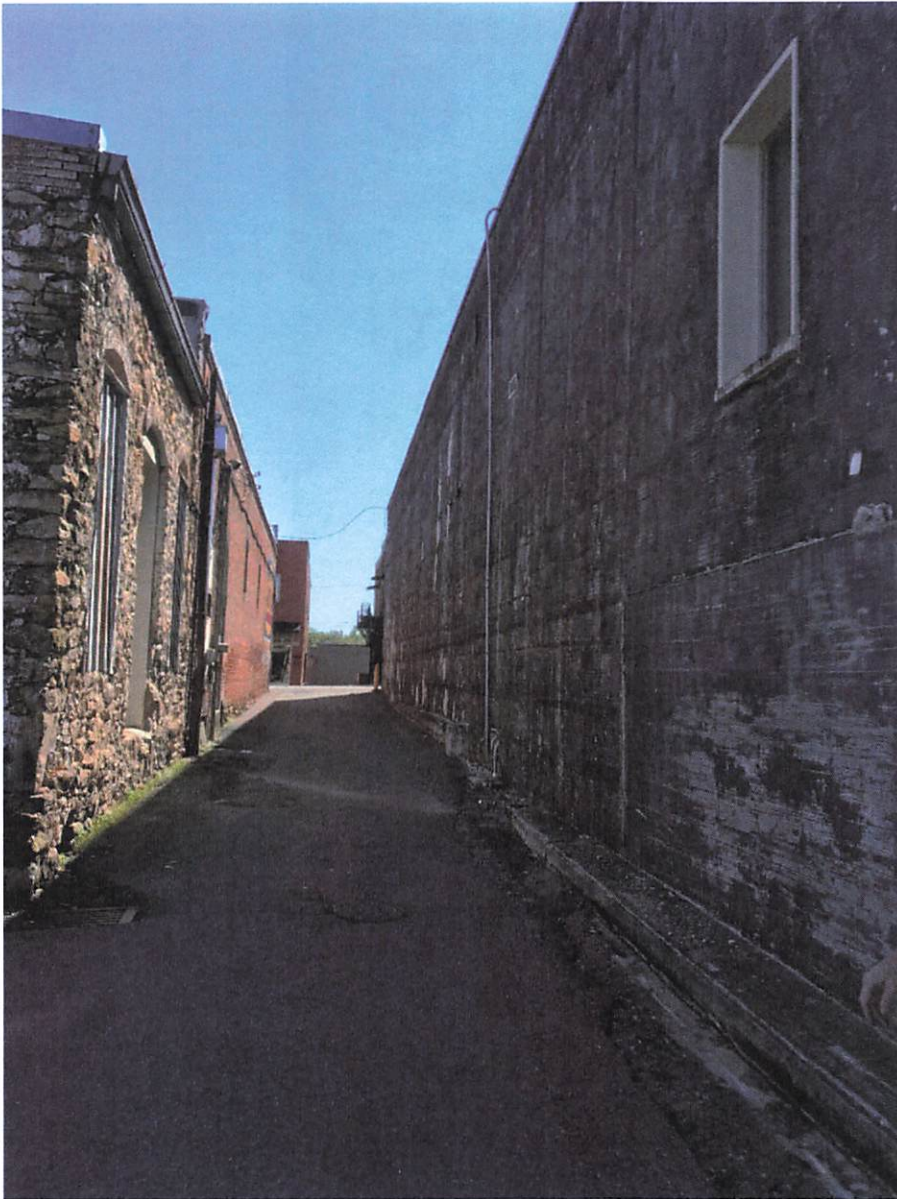
Picture #8. Exterior finish has been removed

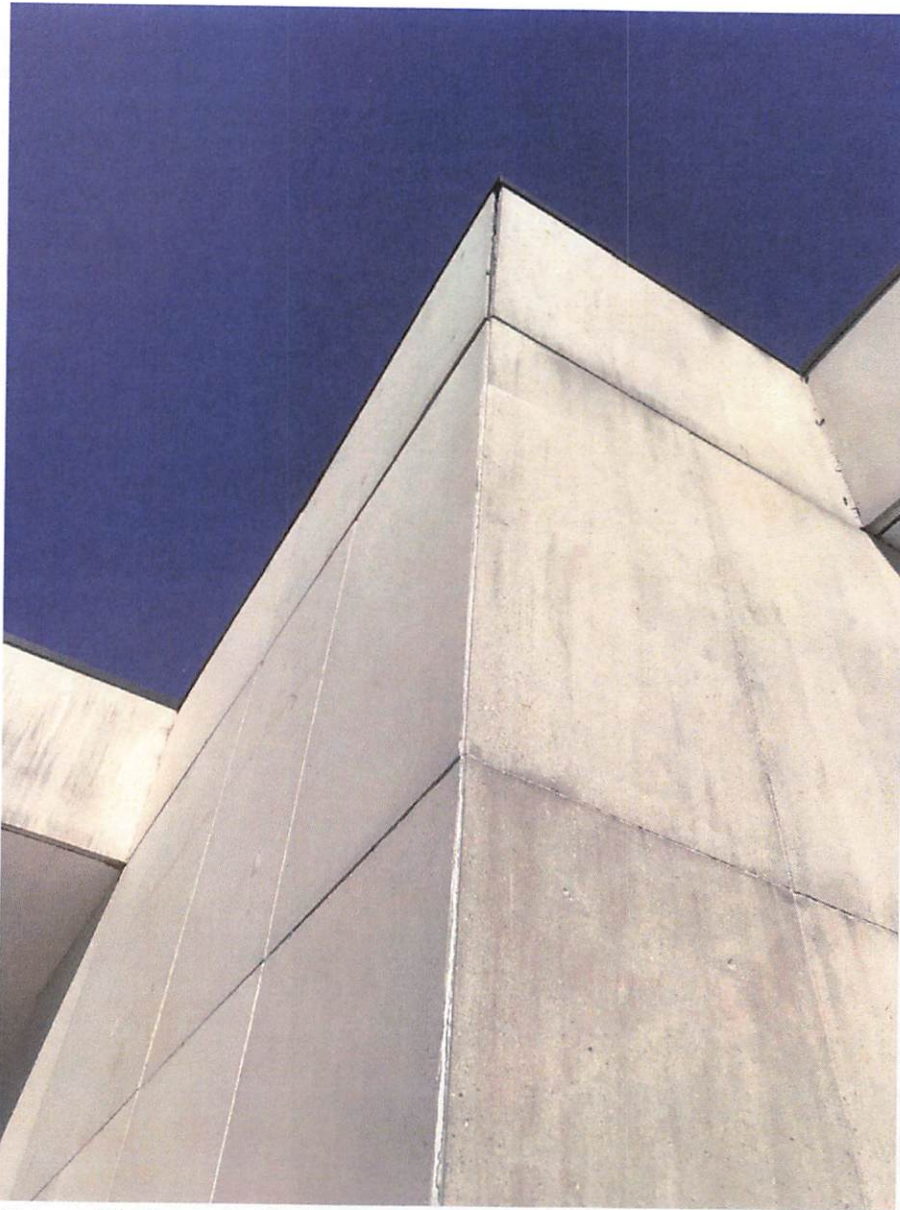
Picture #9. Precast attachment appear to be failing

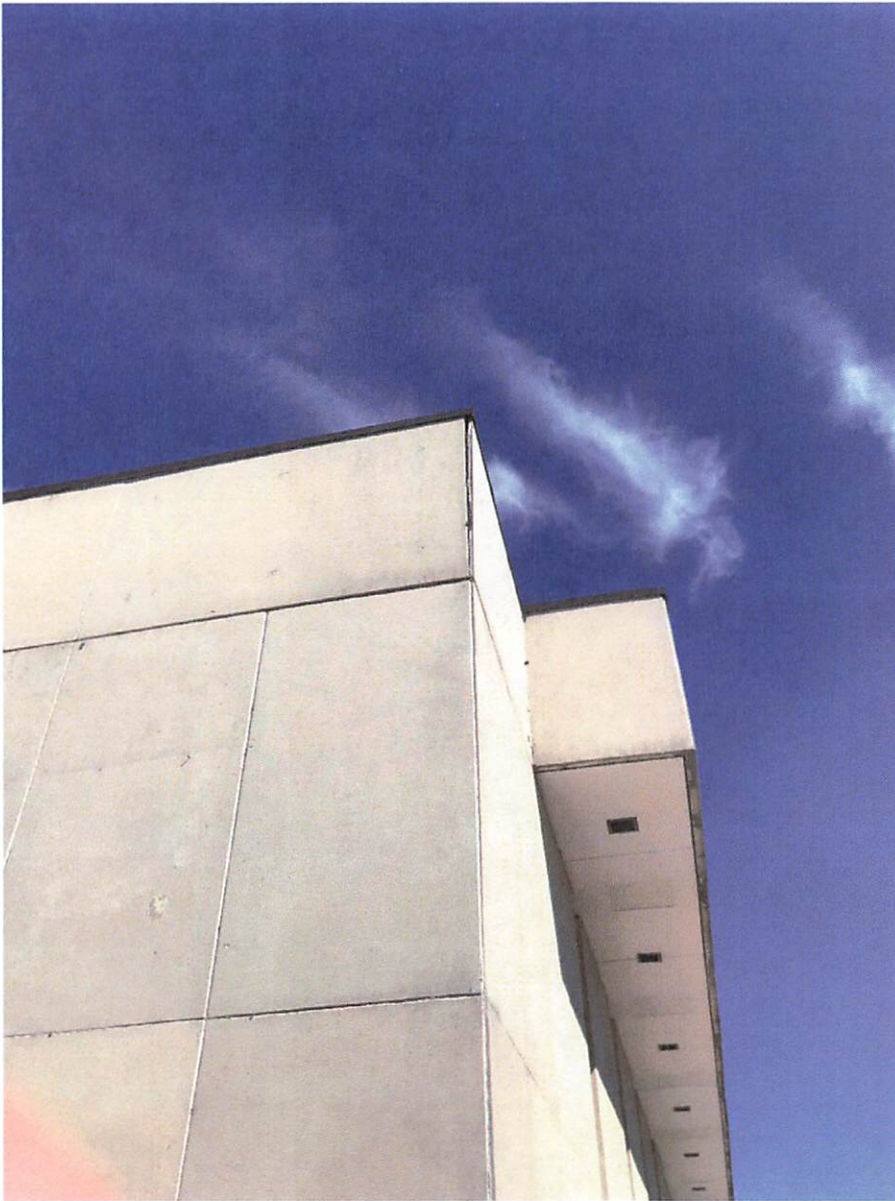
Picture #10. Precast pulling away from building

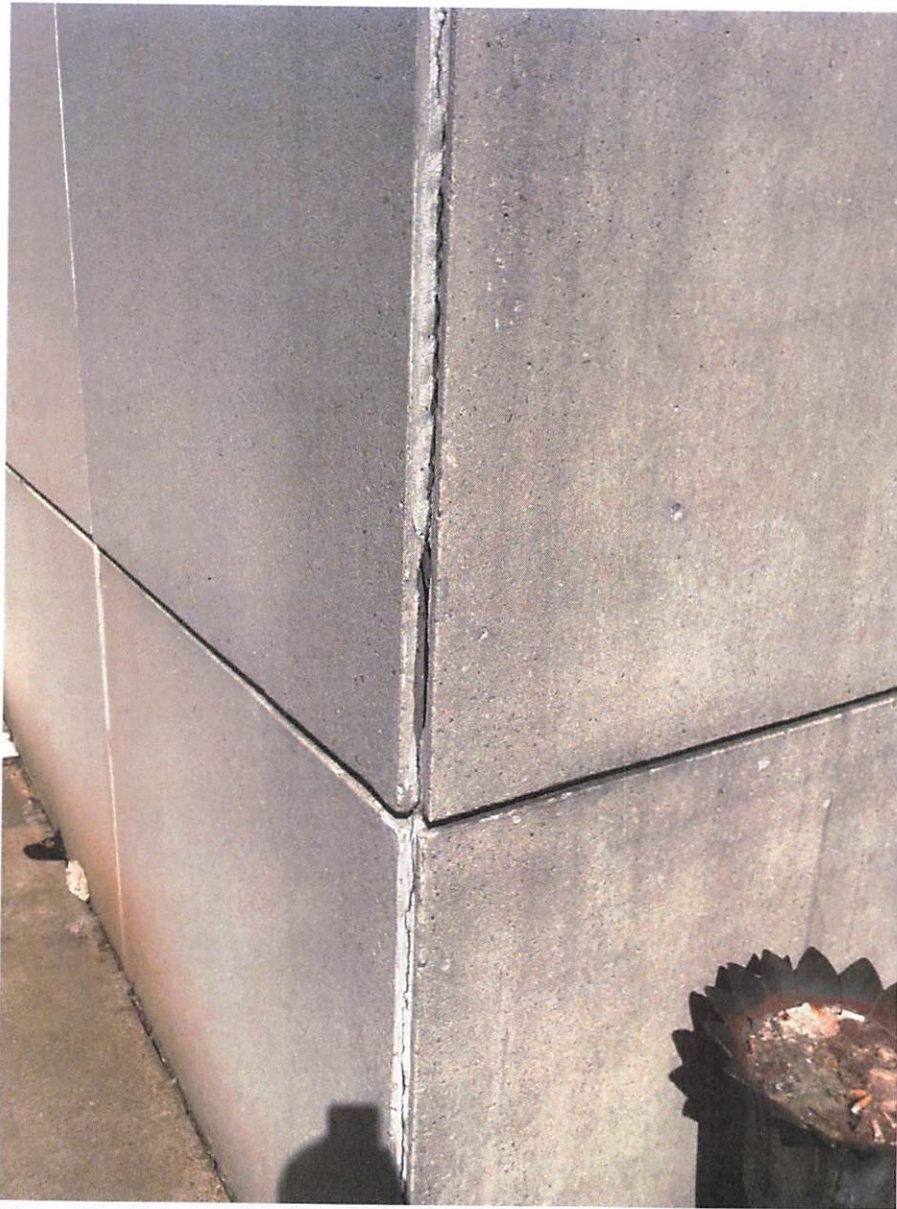
Picture #11. Precast joints appear to be failing

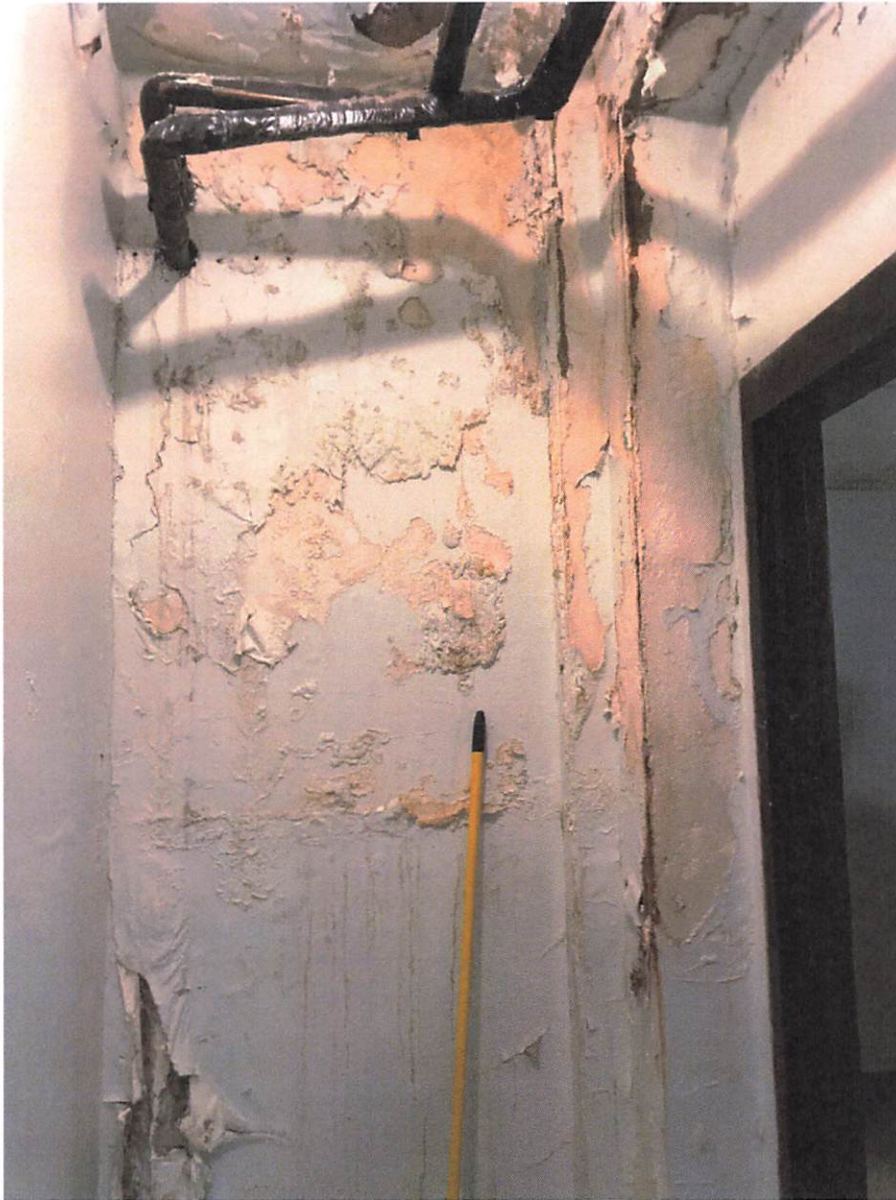
Picture #12. Water intrusion at police department

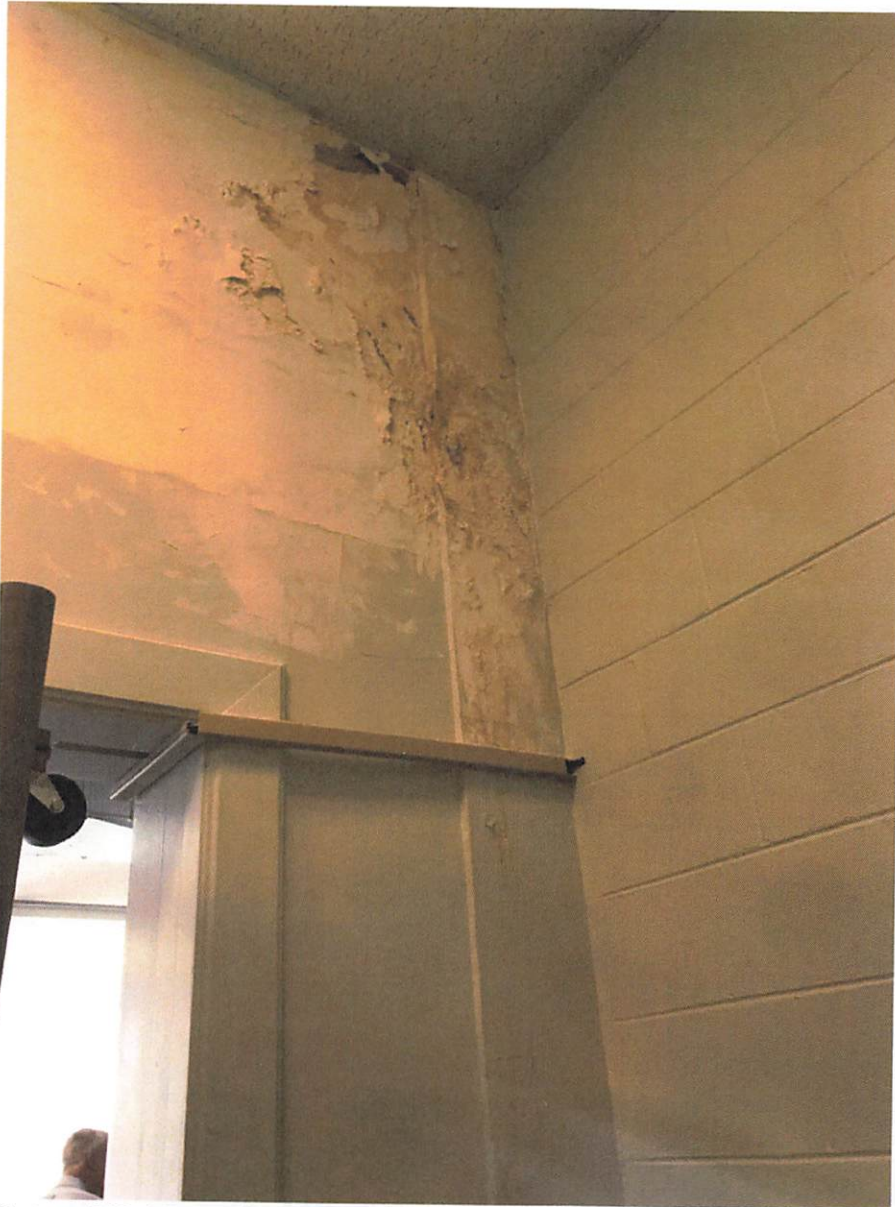
Picture #13. Water damage

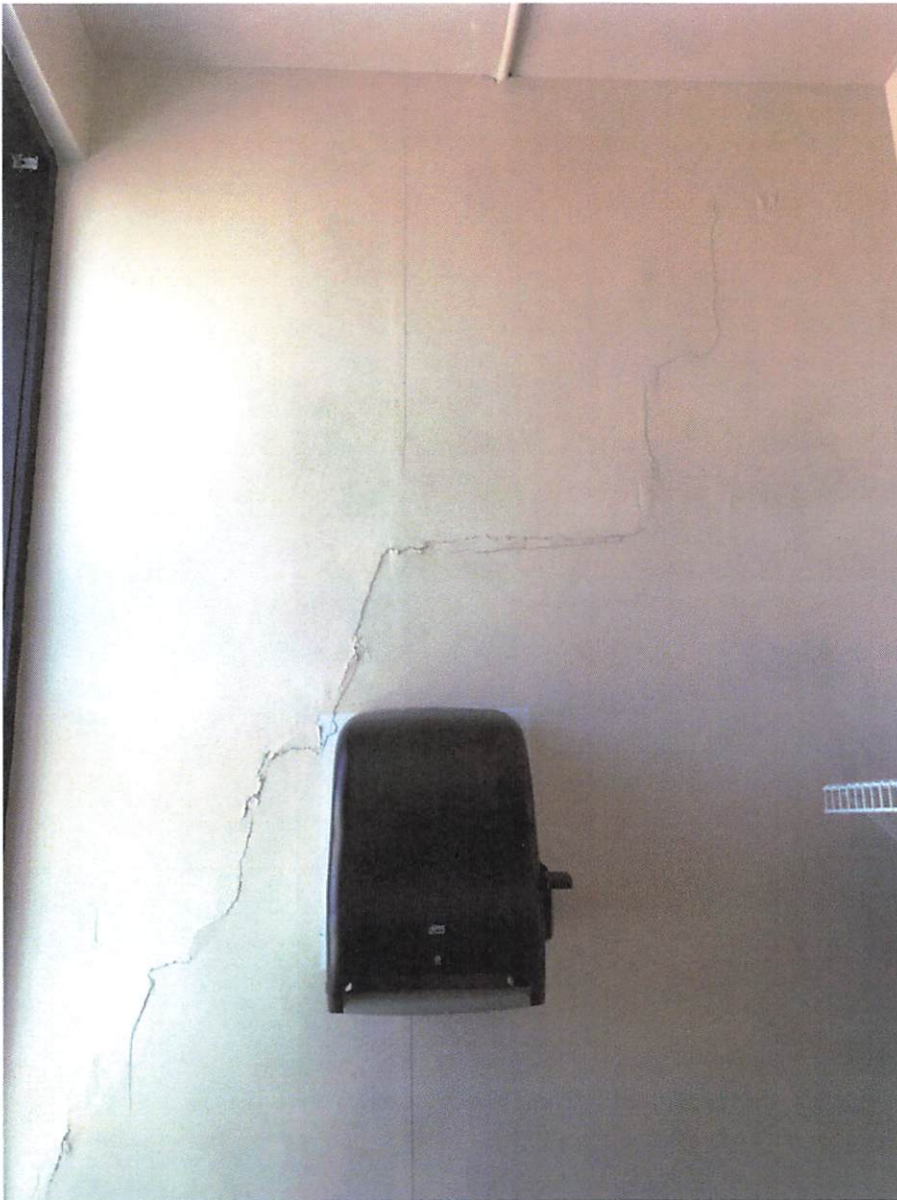
Picture #14. Crack in interior finish

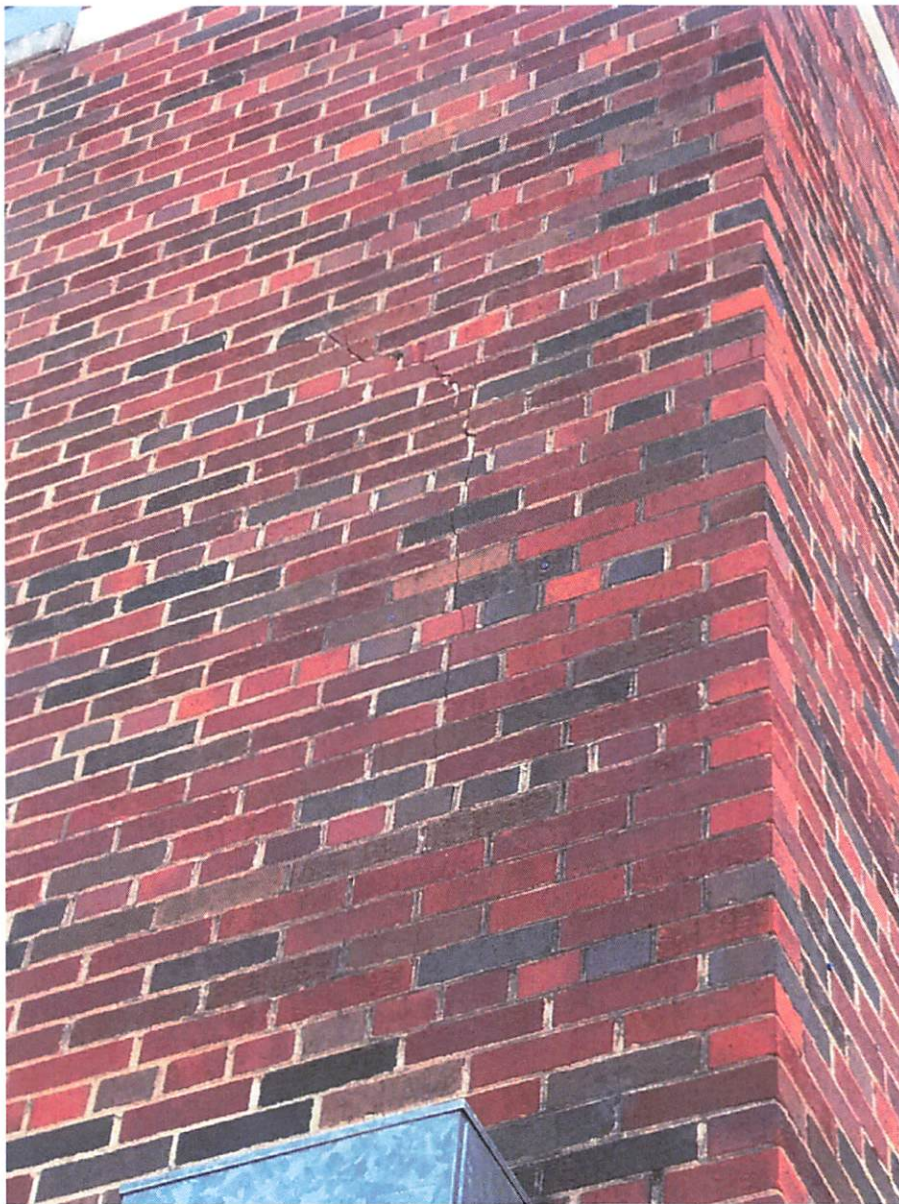
Picture #16. Crack in exterior brick

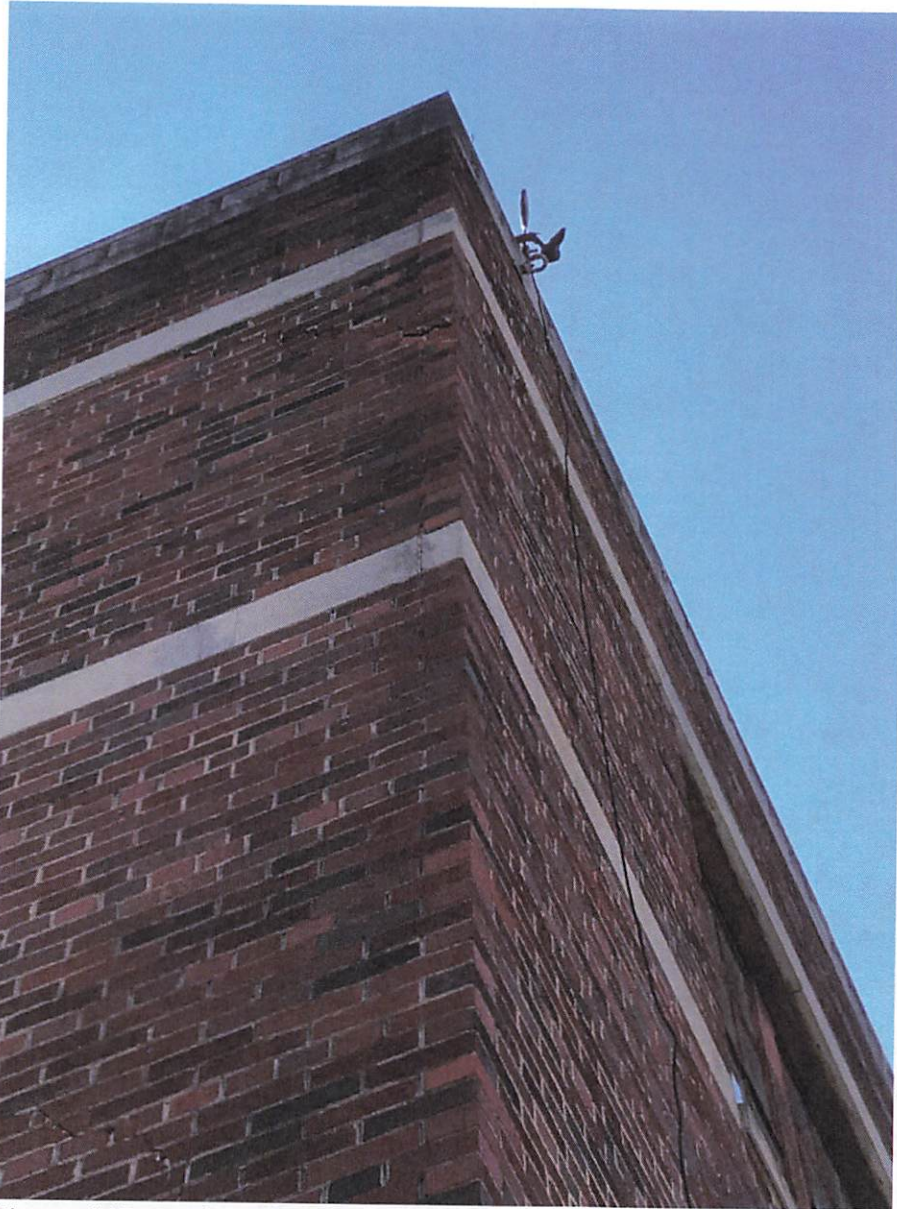
Picture #17. Crack in the exterior brick
