**BUILDING ANALYSIS  
OF**

**ALEXANDER CITY  
POLICE DEPARTMENT  
AND  
CITY HALL**

**ALEXANDER  
CITY  
ALABAMA**

**June 17, 2019**

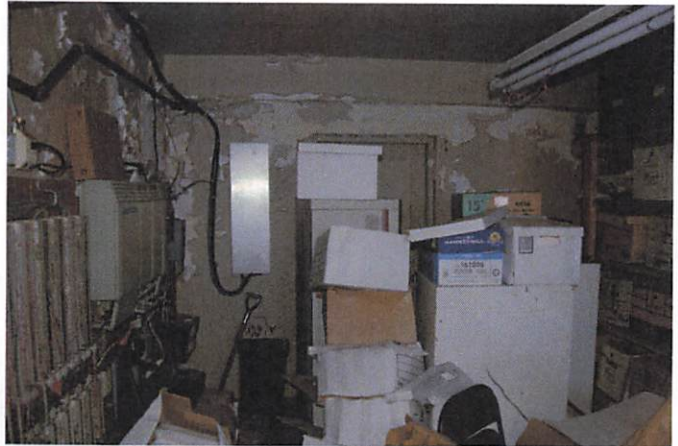
Environmental Materials Consultants, Inc. from Montgomery, Alabama performed a survey of the Police Department Building in 2008 for the City. They were able to use the data from that survey along with observations from this effort to compile their report (see Appendix). As explained in EMC's report, the Police Department Building does contain hazardous/regulated materials including asbestos, fluorescent lamps with mercury, a few fluorescent light fixtures with ballasts containing PCBs, and lead based paint. The report discusses in some detail the requirements for abatement and disposal of these materials. If the building is demolished there will still be requirements for the abatement of some of the materials, but it should not be as extensive as it would be for a renovation.

*Access to Boiler Room where Hazardous Materials were Discovered.*

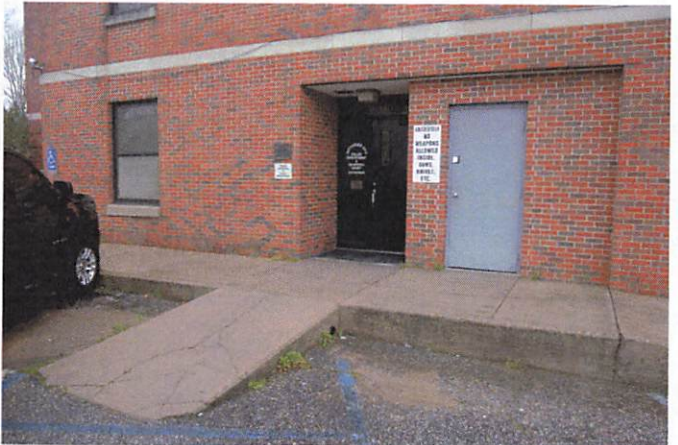
The Police Department Building has a number of non-compliant accessibility issues. Only one entrance located on the north side, ground floor is marked as accessible and it is not compliant. The ADA requires that the number of accessible entrances to be provided shall match the number of required exits, which would be at least two for this facility. The other non-compliant entrances should have signage directing handicapped users to an accessible entrance.

*Current ADA Entrance*

The handicap parking and ramps that serve the north entrance need to be upgraded. Parking signage and striping needs to be corrected. A van-accessible space needs to be added and the ramps need to have handrails added.

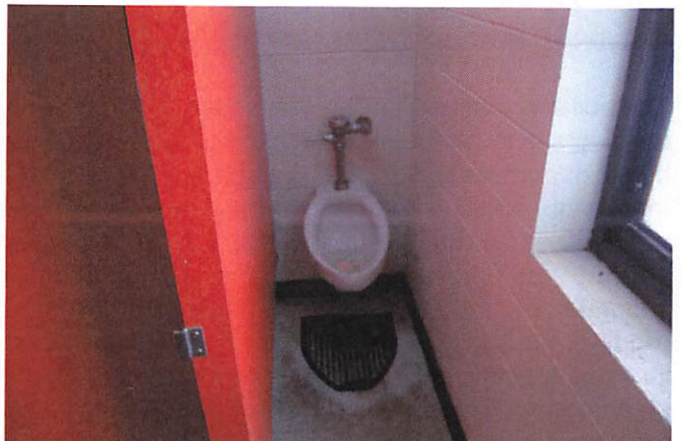
The toilets in the 1982 wing are not completely accessible but should not require major work to be made compliant. The remaining toilets in the building, which are generally small single user rooms are, for the most part, not accessible and would not be worth renovating. Additional restroom facilities, if needed, might be constructed in the location of the old jail cells on the Ground Floor. Plumbing exists there now, so constructing new restrooms would be feasible.

*Current Non-Conforming Restroom*

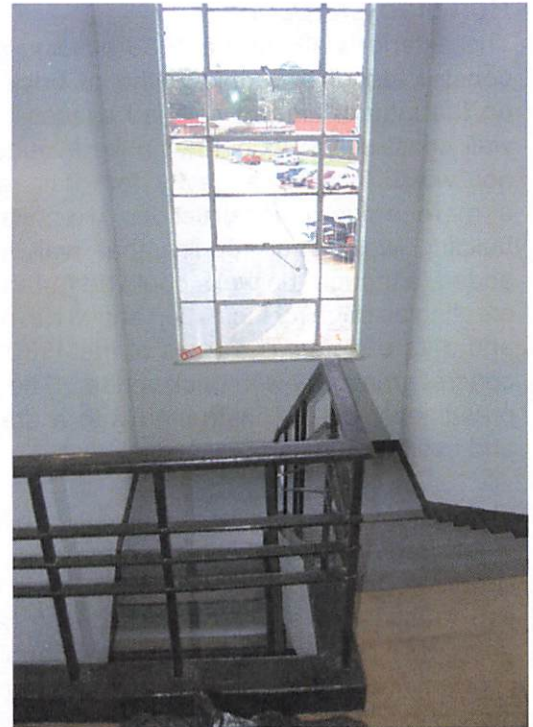
The Police Department Building has two exit stairs. The stair on the east end serves the 2nd and 3rd Floors with an additional interior flight of steps down from the 2nd Floor to grade. The stair on the West end serves all 3 floors and exits on grade. The guardrails and handrails do not comply with current Code requirements. Neither of these stairs is located in an enclosed, fire-rated shaft as required by Code. The code requires that exits stairs be enclosed, but even if enclosed stairs were not required the building would be considered one Fire Area and therefore require sprinklers due to the total square footage. If the building were constructed today, the Courtroom on the 3rd Floor would have to be sprinkled along with the rest of that floor due to the Group A-3 Assembly Occupancy being located in a Fire Area more than one floor above the level of exit discharge.

*Open Stairwell*

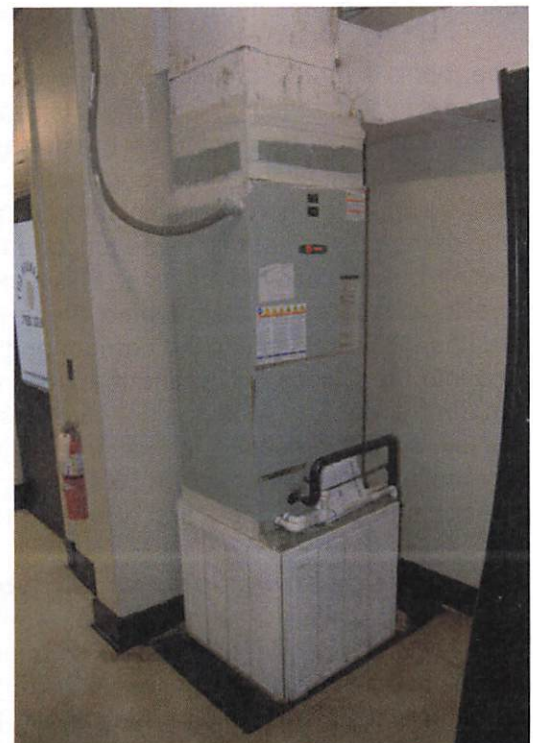
The mechanical systems are free-standing in the corridors. The return air is pulled through the corridors, which is a Code violation.

*Free Standing Mechanical Unit with Corridor Return Air*

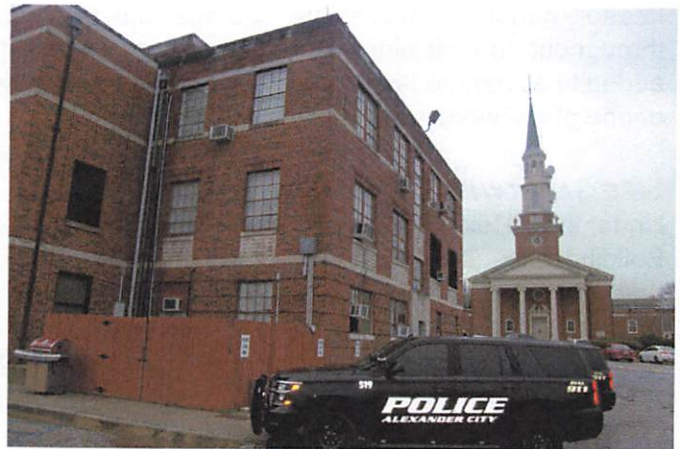
The windows of the 1939 building are single-pane, steel frame window which are in a deteriorated condition. In a number of places the original panes and muntins have been replaced with larger panes. They offer no insulation and are probably subject to condensation when humidity and temperature are not optimal. There are at least 14 window unit air conditioners currently installed in these windows. The windows in the addition are aluminum frame, insulated units that are more energy efficient than the 1939 units.

*Uninsulated Steel Windows*

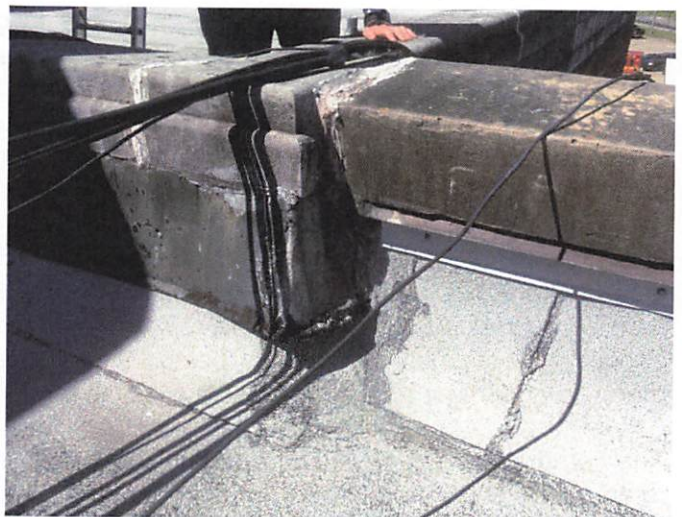
The roof is a modified bitumen roof system. The roof appears to be in reasonable shape with two exceptions. 1) Ponding water was noted on the northeast area of the roof at the junction of the original building and the 1982 addition. 2) There is a major leak on the northwest side of the building at this same juncture between the original building and the addition. This leak is probably due to a flashing problem where these parapets tie together. It is leaking into the corridor on the 3rd Floor and into the Chief's Office and the Training Room on the 2nd Floor. The roof was not cored as part of this survey, so the presence, condition and thickness of any roof insulation is unknown. Rainwater is removed through parapet scuppers and downspout.

*Area of Major Leak*

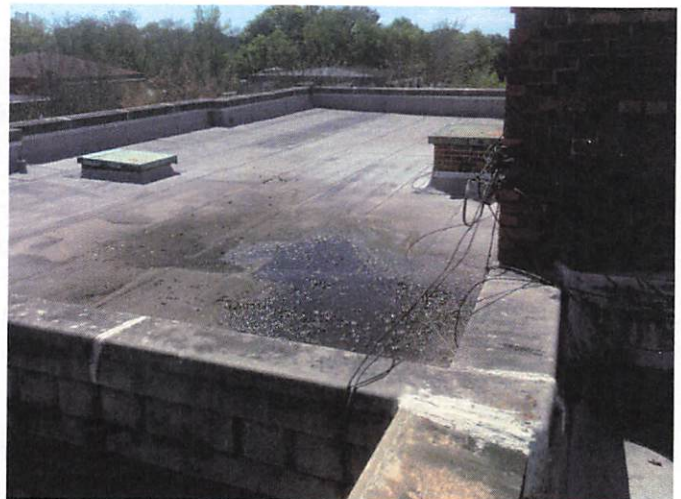
*Ponding Water*

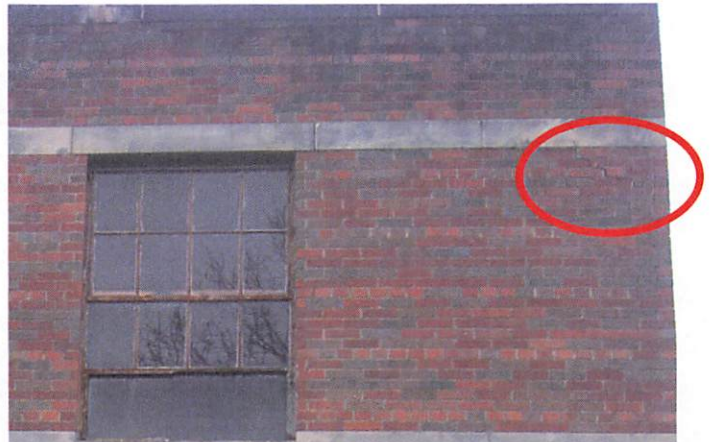
The 1939 building appears to be a concrete framed structure with brick masonry exterior. The 1982 addition is steel framed with concrete floors on metal deck. The Structural Report (see Appendix) noted stepped cracking in the brick on some of the exterior corners of the building. These should be patched and monitored for worsening conditions. According to the report there do not appear to be any major structural concerns.

*Cracks in Masonry*

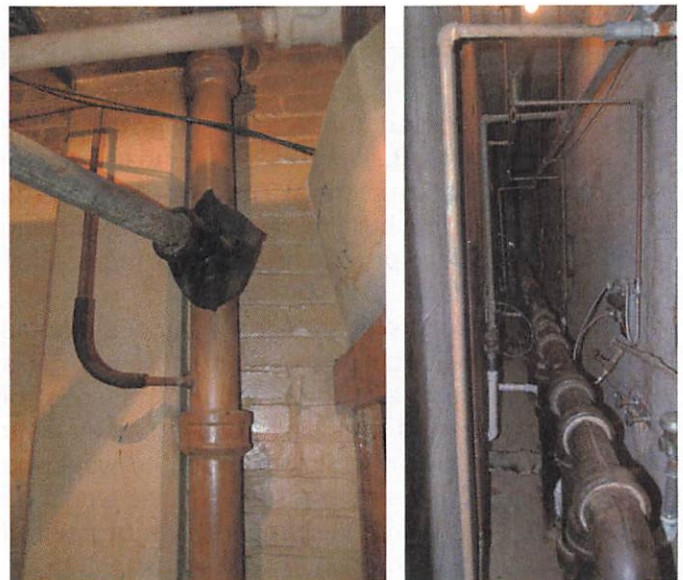
The plumbing in the original part of the Police Department Building is 80 years old and should be replaced if the building is renovated.

*Existing Plumbing*

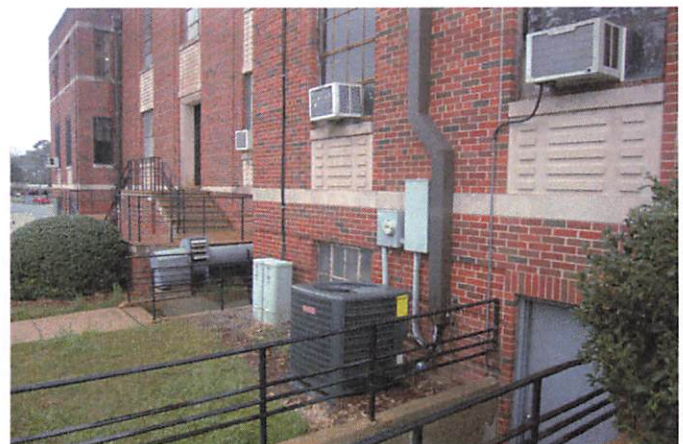
The original 1939 building was not air conditioned. Window units and free-standing central units have been added over the years. The central units do not meet Code. If the building is renovated a complete new system should be installed (See Appendix).

*Diverse Mixture of Mechanical Systems*

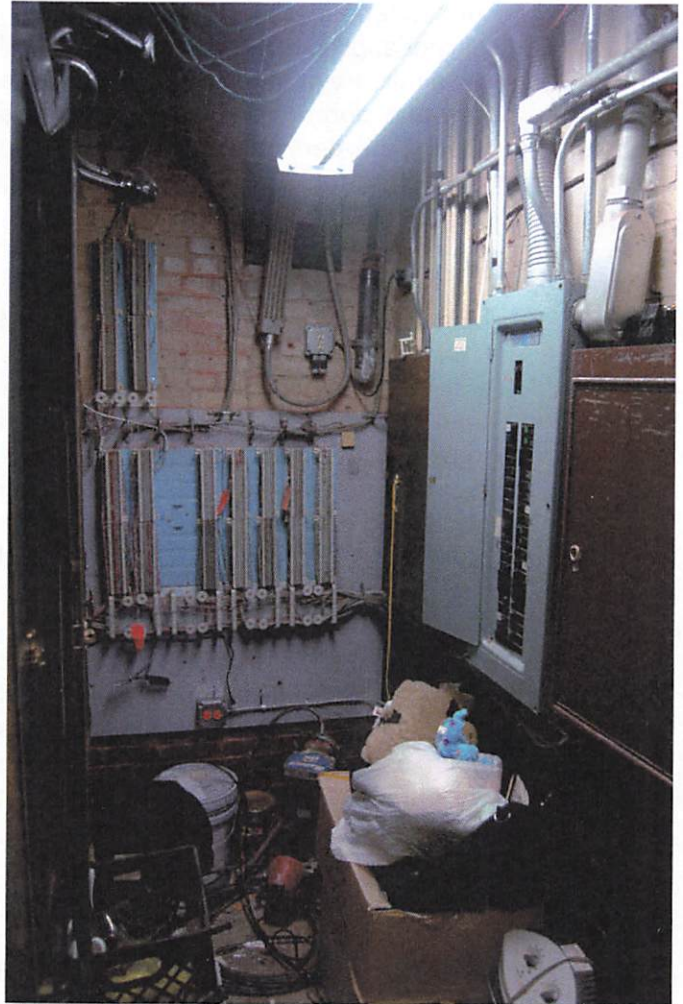
The Electrical Report (see Appendix) should be reviewed, and Code deficiencies in the electrical system should be corrected. The Electrical Report indicates that the electrical system is out-dated and there may not be parts available to repair panels, replace breakers, etc. The building appears to have multiple services, but that could not be verified. The

building lacks electrical outlets and there are a number of plug strips in use which could be a fire hazard. The main electrical room has wiring conditions that are not Code compliant. Lighting is a mix of incandescent and older fluorescent fixtures and is not energy efficient. There is no lighting control system. There is no fire alarm system.

*Existing Electrical Service*

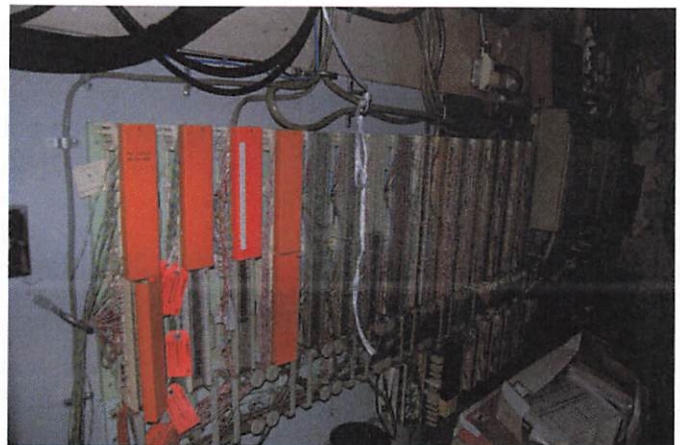
*Existing Telephone/Low Voltage System*
