## CITY HALL BUILDING

### **GENERAL DESCRIPTION**

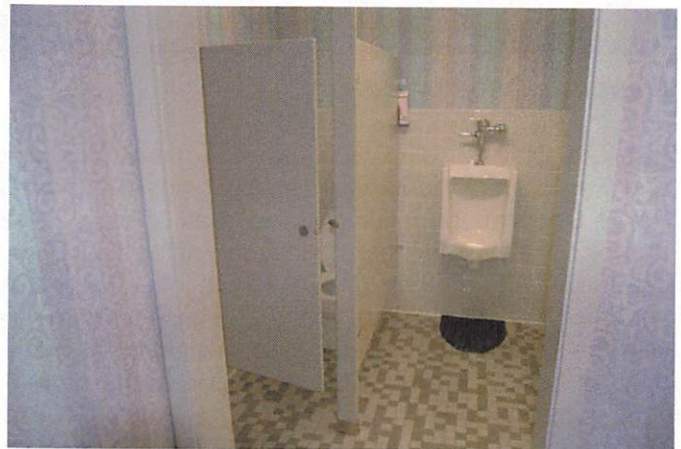
*Non-Compliant Inaccessible Bathrooms*

Restrooms are located on the lower level of the main floor at the west end of the lobby and on the intermediate level above the upper level of the main floor. The main floor restrooms can be adjusted to comply with ADA requirements. The intermediate level restrooms cannot be reached by an accessible route and will require major configuration to be accessible and will require a reduction in toilet fixture count.

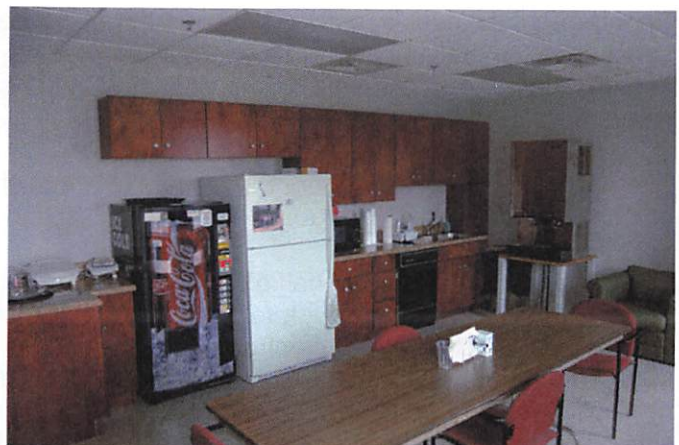
*Break-room on Inaccessible Level*

While the plumbing systems appear to be in good working condition, it is recommended that they be replaced if the building undergoes an extensive renovation. In any event, the toilets and breakroom on the Intermediate floor are not accessible.

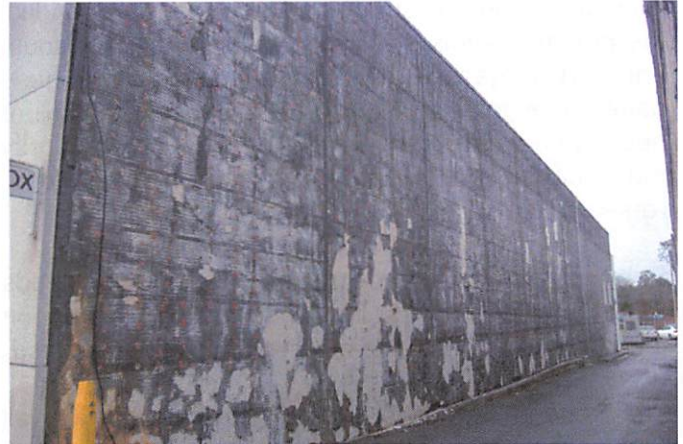
The north wall had a stucco finish system which has been removed due to cracking. The masonry and concrete substrate remains, partially covered with what appears to be building paper or felt that was the weather barrier for the stucco. This wall needs to be cleaned back to the brick and sealed or covered with an exterior finish. The joint between this wall and the precast panels at the northeast corner of the building needs to be covered to prevent intrusion of water and vermin.

*Exposed Wall Substrate where Stucco Removed*

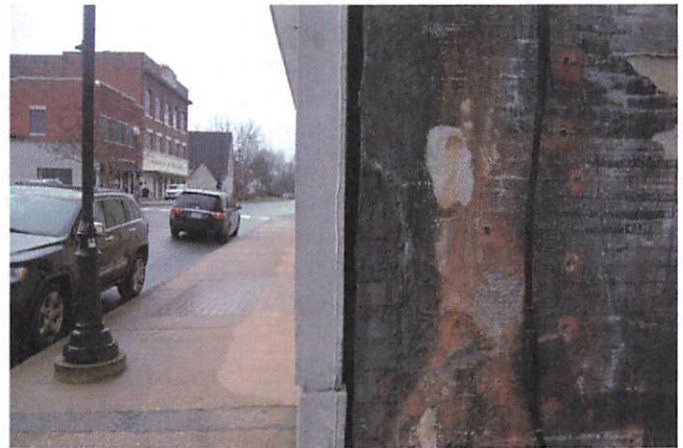
*Unprotected Joint at Corner*

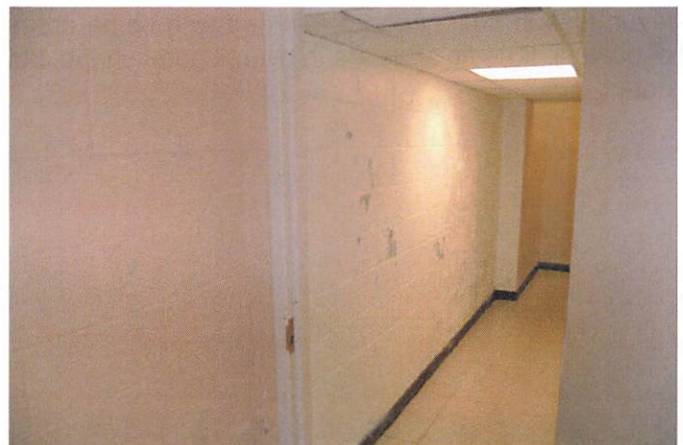
The walls below grade on the interior at the north side are experiencing water intrusion. As part of the work to protect this north wall, the cause of this water intrusion should be assessed and remediated. It is possible, but unlikely that a negative-side waterproofing material might solve this problem. That would be the least expensive fix, but again, may not correct the problem.

*Water Intrusion at Lower Level*

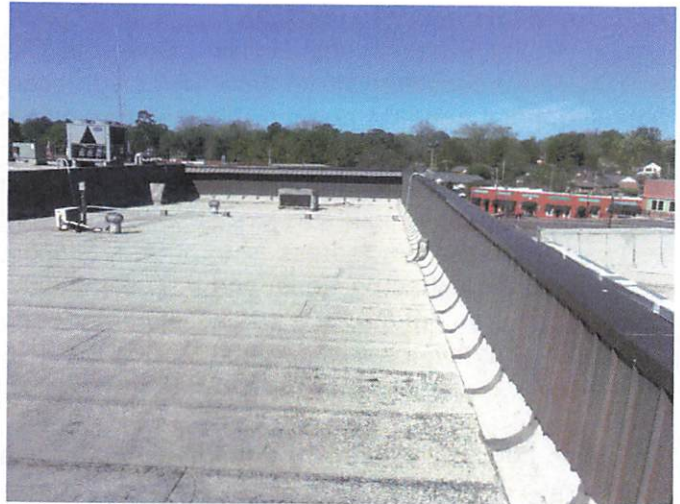
The roof is a modified bitumen system that appears to be in good shape. The northern half of the building, which is an older wood and masonry structure has the roof deck depressed lower than the surrounding parapet walls. Both halves of the roof are dependent on roof drains and interior rain leaders, however the north side is also dependent on emergency overflow drains if the roof drains are stopped. On the southern side water can flow over the roof edge in the event of a stoppage. The roof hatch needs to be replaced.

*Existing Roof*

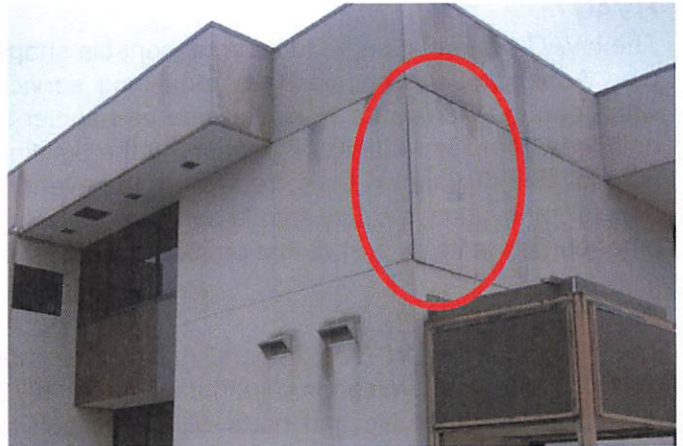
As indicated in the Structural Report (see Appendix), the precast panels at the corners on the east, south and part of the west face exhibit movement. These panels need to be removed and the cause of the failure needs to be assessed. This should be a high priority maintenance item. All of the precast joints need to be re-sealed.

*Movement in Pre-Cast Panels*

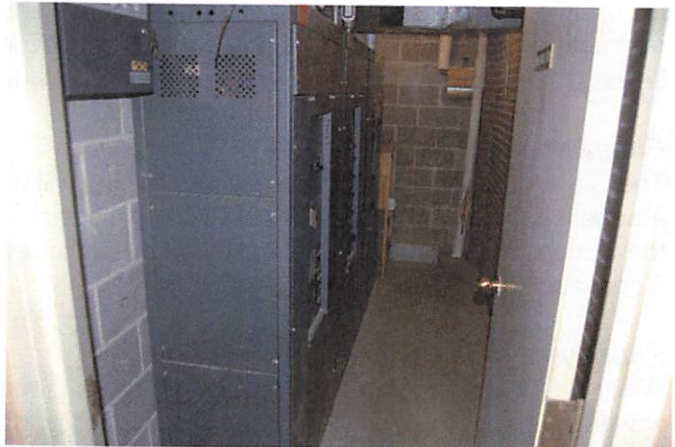
The Electrical Report (see Appendix) indicates that the main electrical switchboard manufactured in 1972 is past its expected life and parts will be difficult to obtain if they are even available. Other distribution panels throughout the building are the same age and will have the same problem with parts availability. The conductors and their insulation is old. The light fixtures are older fluorescent and incandescent fixtures that are not energy efficient and would not meet current energy Code. There is no lighting control system, which would be required to meet current Code requirements.

*Existing Electrical Service*
