BUILDING ANALYSIS OF

ALEXANDER CITY POLICE DEPARTMENT AND CITY HALL

**ALEXANDER
CITY**
ALABAMA

June 17, 2019

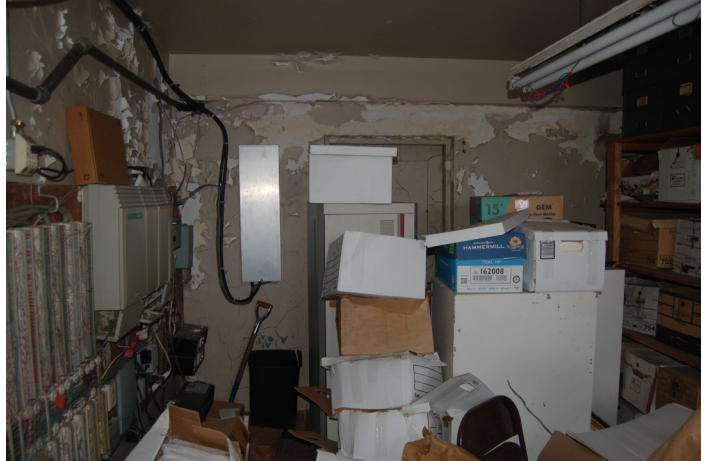
Environmental Materials Consultants, Inc. from Montgomery, Alabama performed a survey of the Police Department Building in 2008 for the City. They were able to use the data from that survey along with observations from this effort to compile their report (see Appendix). As explained in EMC's report, the Police Department Building does contain hazardous/regulated materials including asbestos, fluorescent lamps with mercury, a few fluorescent light fixtures with ballasts containing PCBs, and lead based paint. The report discusses in some detail the requirements for abatement and disposal of these materials. If the building is demolished there will still be requirements for the abatement of some of the materials, but it should not be as extensive as it would be for a renovation.

Access to Boiler Room where Hazardous Materials were Discovered.

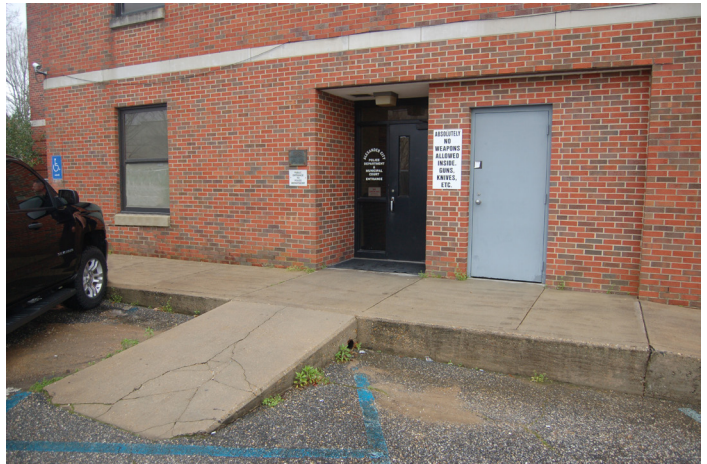
The handicap parking and ramps that serve the north entrance need to be upgraded. Parking signage and striping needs to be corrected. A van-accessible space needs to be added and the ramps need to have handrails added.

Current ADA Entrance

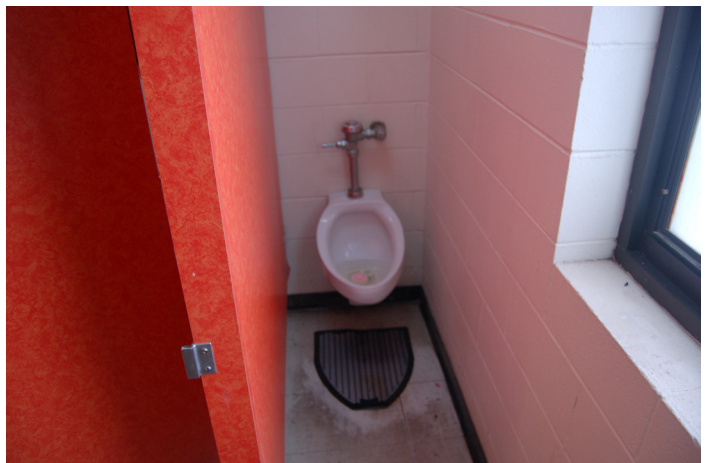
The toilets in the 1982 wing are not completely accessible but should not require major work to be made compliant. The remaining toilets in the building, which are generally small single user rooms are, for the most part, not accessible and would not be worth renovating. Additional restroom facilities, if needed, might be constructed in the location of the old jail cells on the Ground Floor. Plumbing exists there now, so constructing new restrooms would be feasible.

Current Non-Conforming Restroom

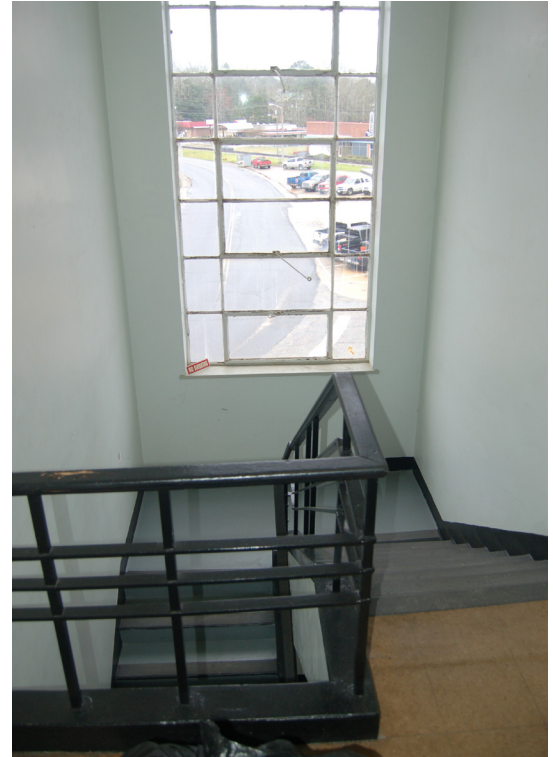
To summarize, from a Life Safety and Fire Protection standpoint the building does not meet the requirements of the 2015 IBC and associated Codes. These conditions are probably considered “grandfathered” by the Fire Marshal and Building Official as allowed by the Code. However, if the building is renovated or altered in a significant way or if the Occupancy of the building changes, these officials will likely require the deficiencies to be corrected.

Open Stairwell

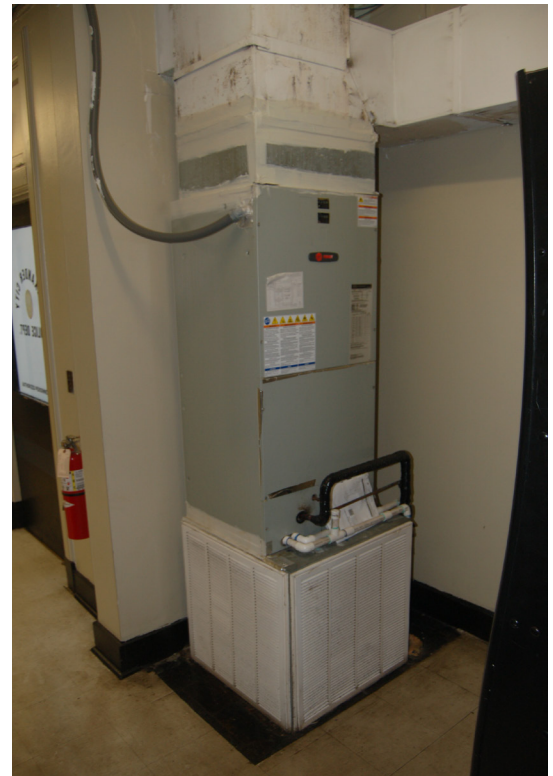
The mechanical systems are free-standing in the corridors. The return air is pulled through the corridors, which is a Code violation.

Free Standing Mechanical Unit with Corridor Return Air

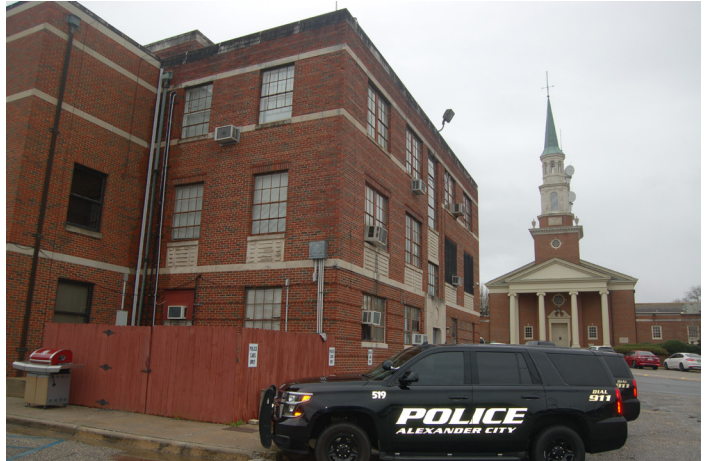
Uninsulated Steel Windows

The windows of the 1939 building are single-pane, steel frame window which are in a deteriorated condition. In a number of places the original panes and muntins have been replaced with larger panes. They offer no insulation and are probably subject to condensation when humidity and temperature are not optimal. There are at least 14 window unit air conditioners currently installed in these windows. The windows in the addition are aluminum frame, insulated units that are more energy efficient than the 1939 units.

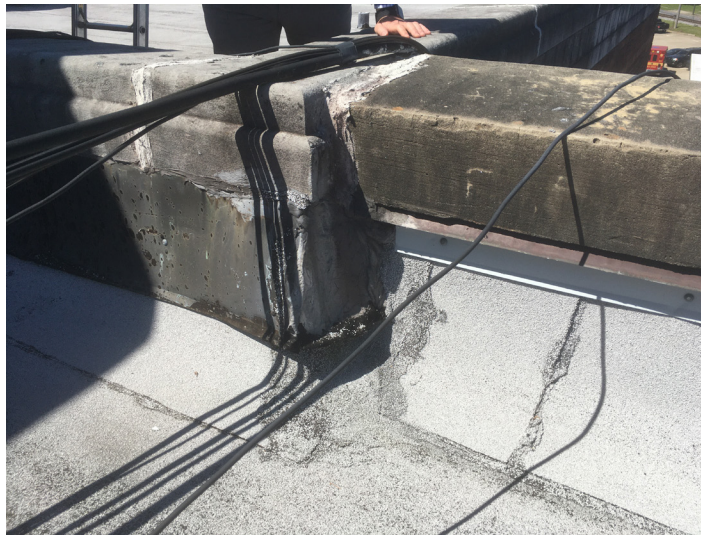
Area of Major Leak

The roof is a modified bitumen roof system. The roof appears to be in reasonable shape with two exceptions. 1) Ponding water was noted on the northeast area of the roof at the junction of the original building and the 1982 addition. 2) There is a major leak on the northwest side of the building at this same juncture between the original building and the addition. This leak is probably due to a flashing problem where these parapets tie together. It is leaking into the corridor on the 3rd Floor and into the Chief's Office and the Training Room on the 2nd Floor. The roof was not cored as part of this survey, so the presence, condition and thickness of any roof insulation is unknown. Rainwater is removed through parapet scuppers and downspout.

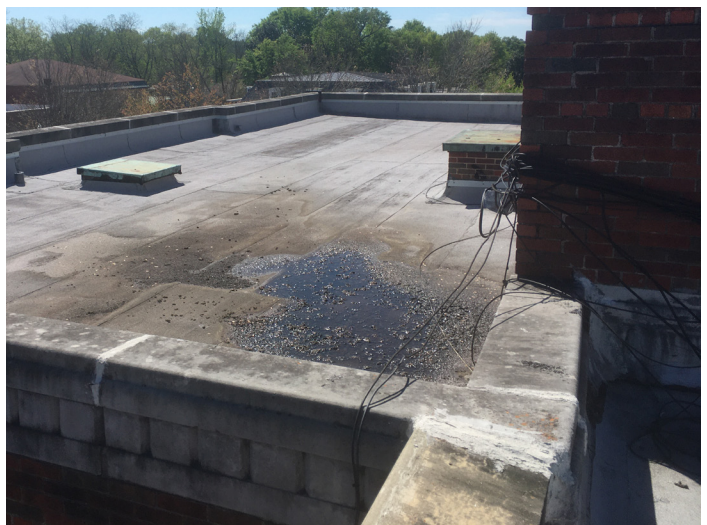
Ponding Water

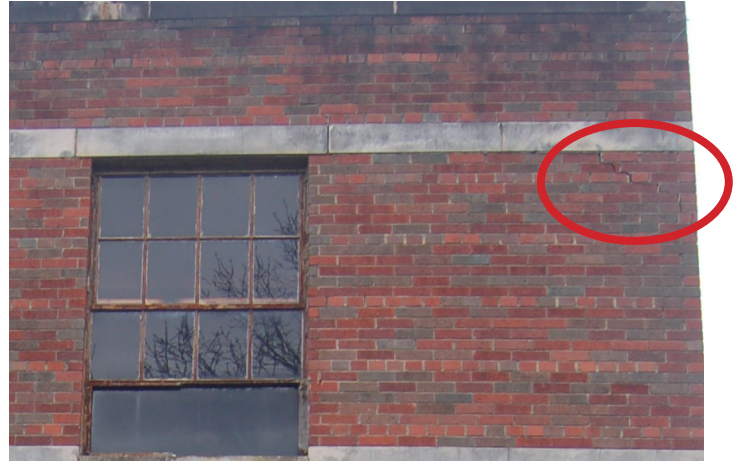
The 1939 building appears to be a concrete framed structure with brick masonry exterior. The 1982 addition is steel framed with concrete floors on metal deck. The Structural Report (see Appendix) noted stepped cracking in the brick on some of the exterior corners of the building. These should be patched and monitored for worsening conditions. According to the report there do not appear to be any major structural concerns.

Cracks in Masonry

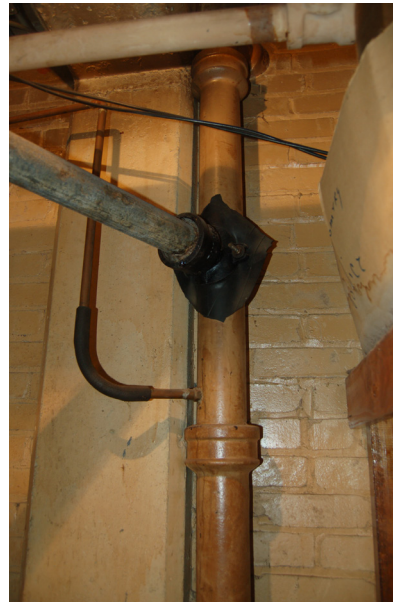
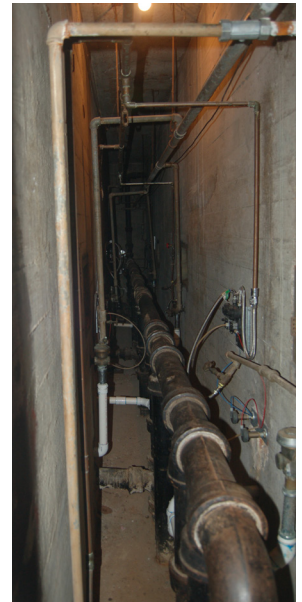
The plumbing in the original part of the Police Department Building is 80 years old and should be replaced if the building is renovated.

Existing Plumbing

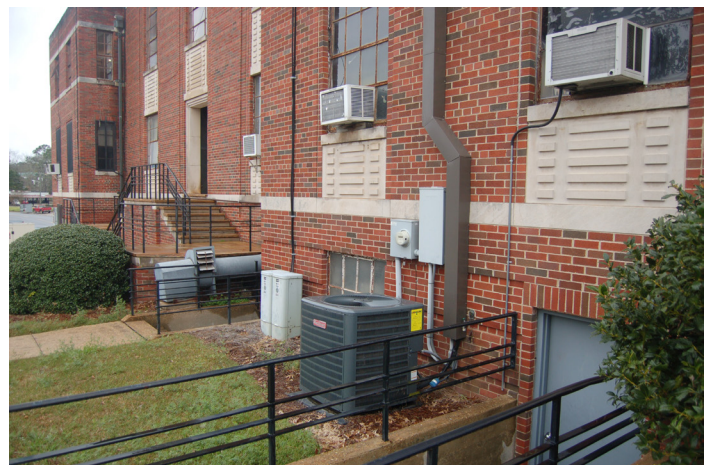
The original 1939 building was not air conditioned. Window units and free-standing central units have been added over the years. The central units do not meet Code. If the building is renovated a complete new system should be installed (See Appendix).

Diverse Mixture of Mechanical Systems

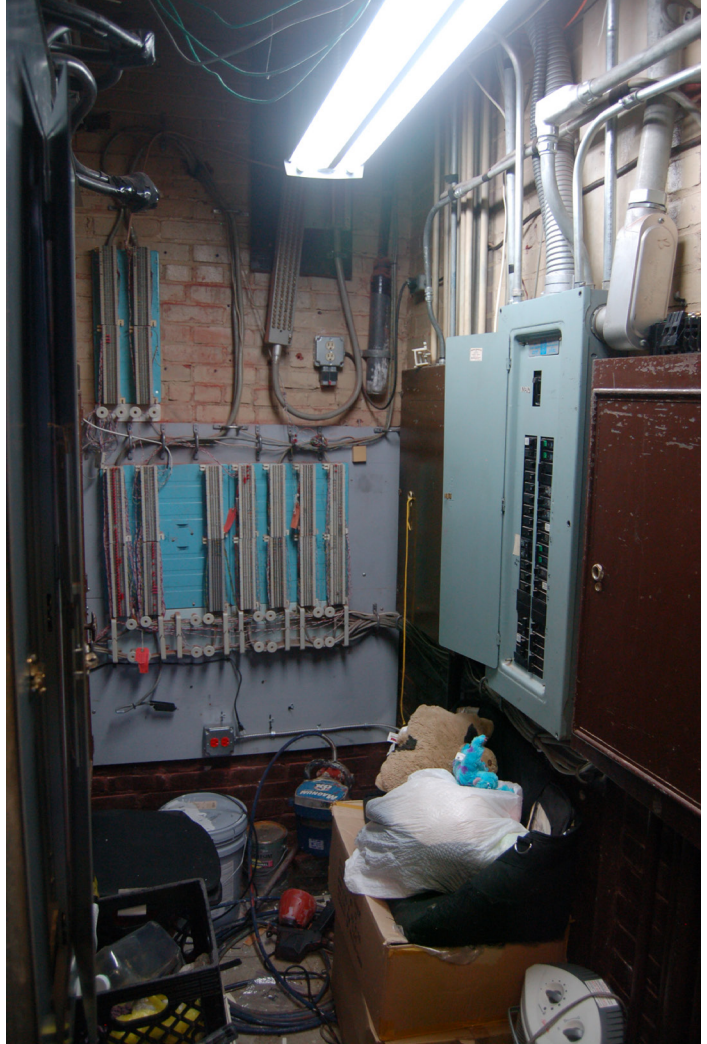
building lacks electrical outlets and there are a number of plug strips in use which could be a fire hazard. The main electrical room has wiring conditions that are not Code compliant. Lighting is a mix of incandescent and older fluorescent fixtures and is not energy efficient. There is no lighting control system. There is no fire alarm system.

Existing Electrical Service

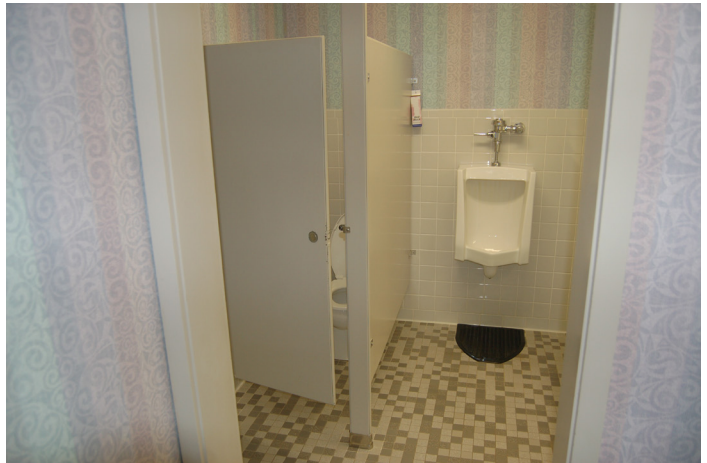
Non-Compliant Inaccessible Bathrooms

Restrooms are located on the lower level of the main floor at the west end of the lobby and on the intermediate level above the upper level of the main floor. The main floor restrooms can be adjusted to comply with ADA requirements. The intermediate level restrooms cannot be reached by an accessible route and will require major configuration to be accessible and will require a reduction in toilet fixture count.

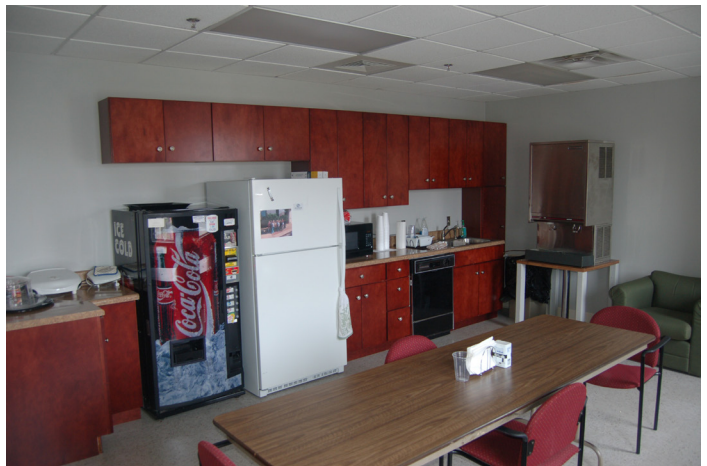
The interior of the building has a number of different levels as indicated above. This makes handicap accessibility to the different levels difficult. The only interior accessible route is between the main floor and the mezzanine by means of the elevator. The elevator serves both levels of the main floor.

Break-room on Inaccessible Level

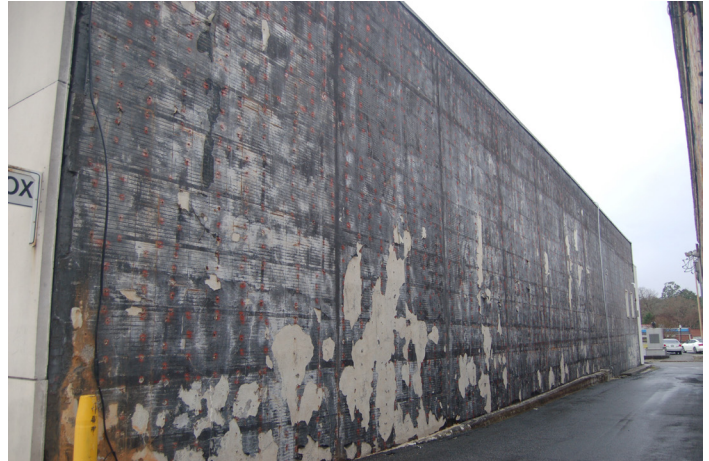
The north wall had a stucco finish system which has been removed due to cracking. The masonry and concrete substrate remains, partially covered with what appears to be building paper or felt that was the weather barrier for the stucco. This wall needs to be cleaned back to the brick and sealed or covered with an exterior finish. The joint between this wall and the precast panels at the northeast corner of the building needs to be covered to prevent intrusion of water and vermin.

Exposed Wall Substrate where Stucco Removed

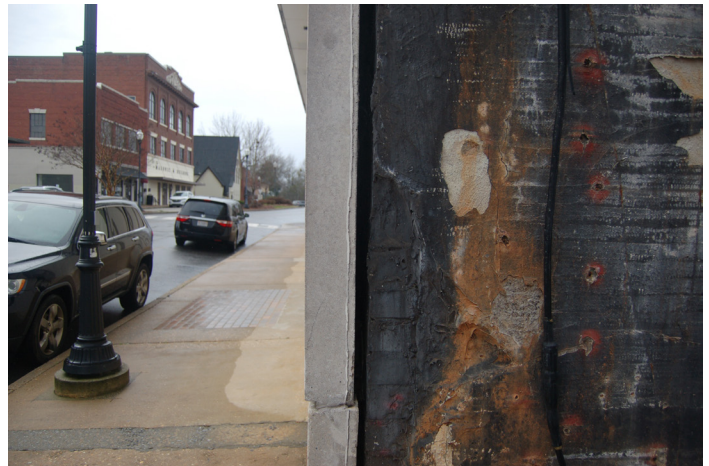
Unprotected Joint at Corner

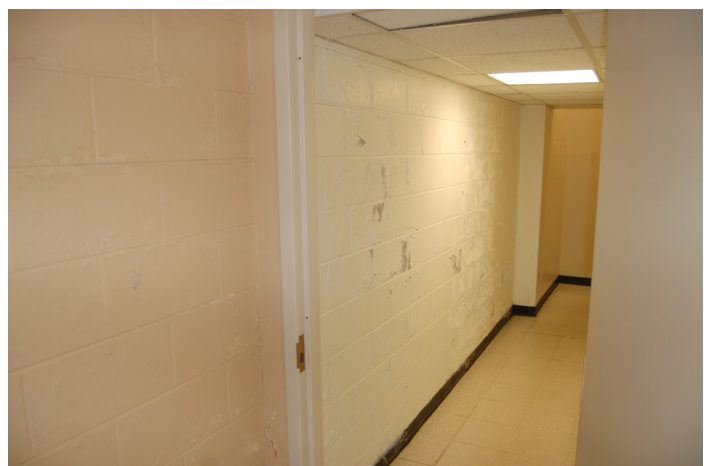
The walls below grade on the interior at the north side are experiencing water intrusion. As part of the work to protect this north wall, the cause of this water intrusion should be assessed and remediated. It is possible, but unlikely that a negative-side waterproofing material might solve this problem. That would be the least expensive fix, but again, may not correct the problem.

Water Intrusion at Lower Level

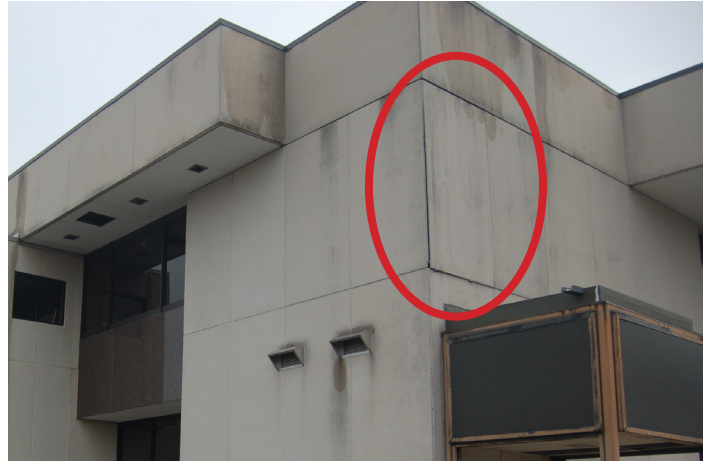
As indicated in the Structural Report (see Appendix), the precast panels at the corners on the east, south and part of the west face exhibit movement. These panels need to be removed and the cause of the failure needs to be assessed. This should be a high priority maintenance item. All of the precast joints need to be re-sealed.

Movement in Pre-Cast Panels

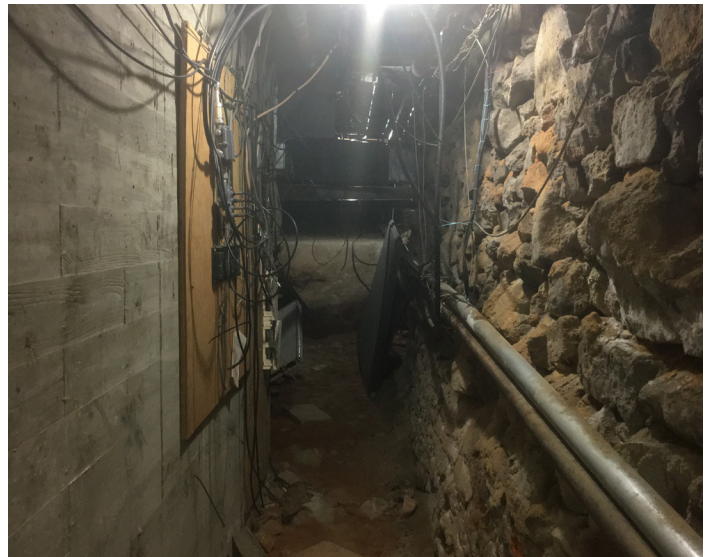
There is a lower level about half of a story (approximately 42") below the main first floor on the west side of the building. The old drive-through teller is located here and houses the sprinkler riser. This lower level includes mechanical, electrical and telephone rooms. Access to the partial basement is from this area down a set of steps with an elevation change of approximately 42 inches. The basement is a storage space and houses the hydraulic elevator equipment and an old vault. It connects to a crawl space that is under the north and east sides of the building. Some of the foundation walls in this area are old masonry walls of uncut stone.

Stone Walls in Crawlspace

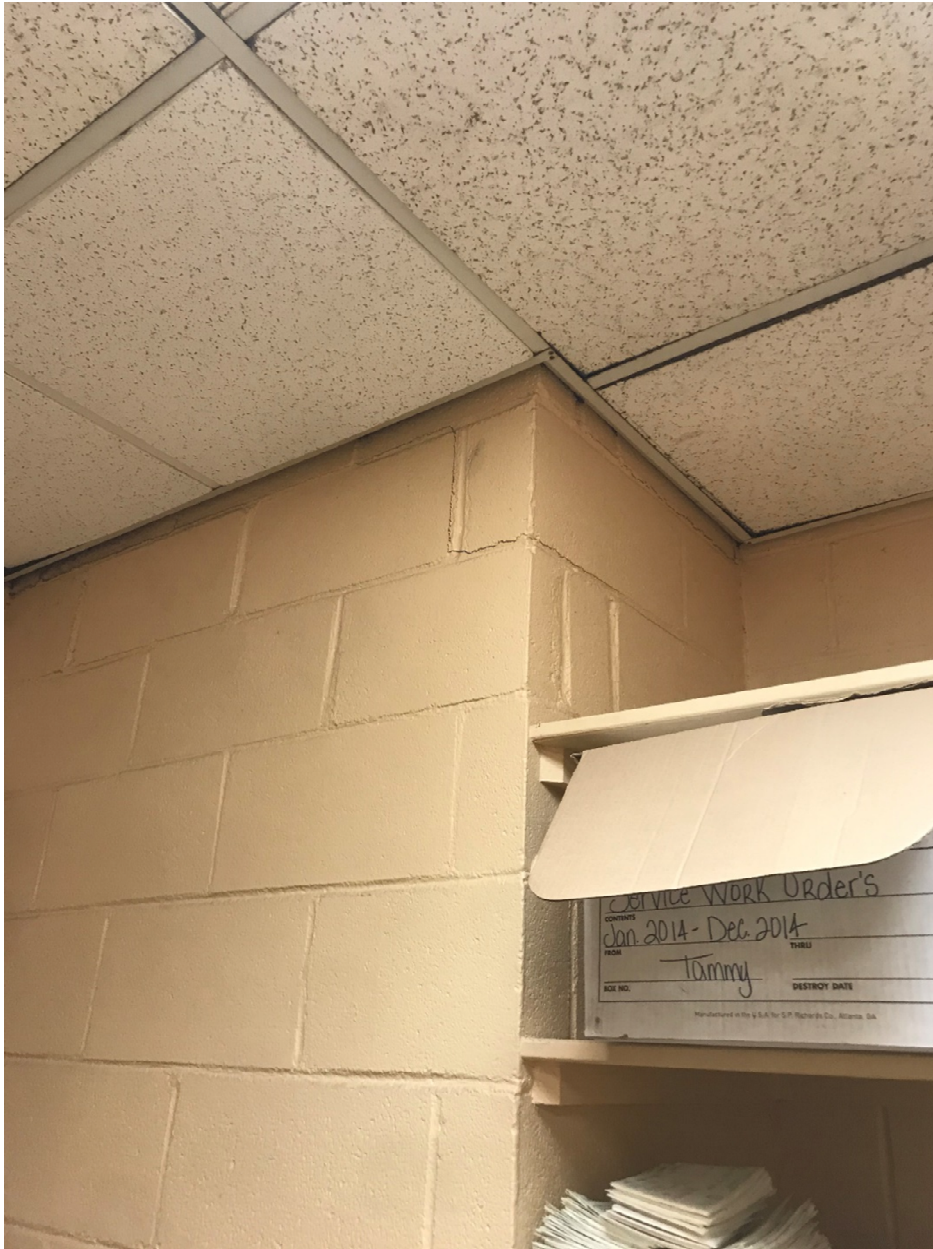
Picture #2. CMU cracks

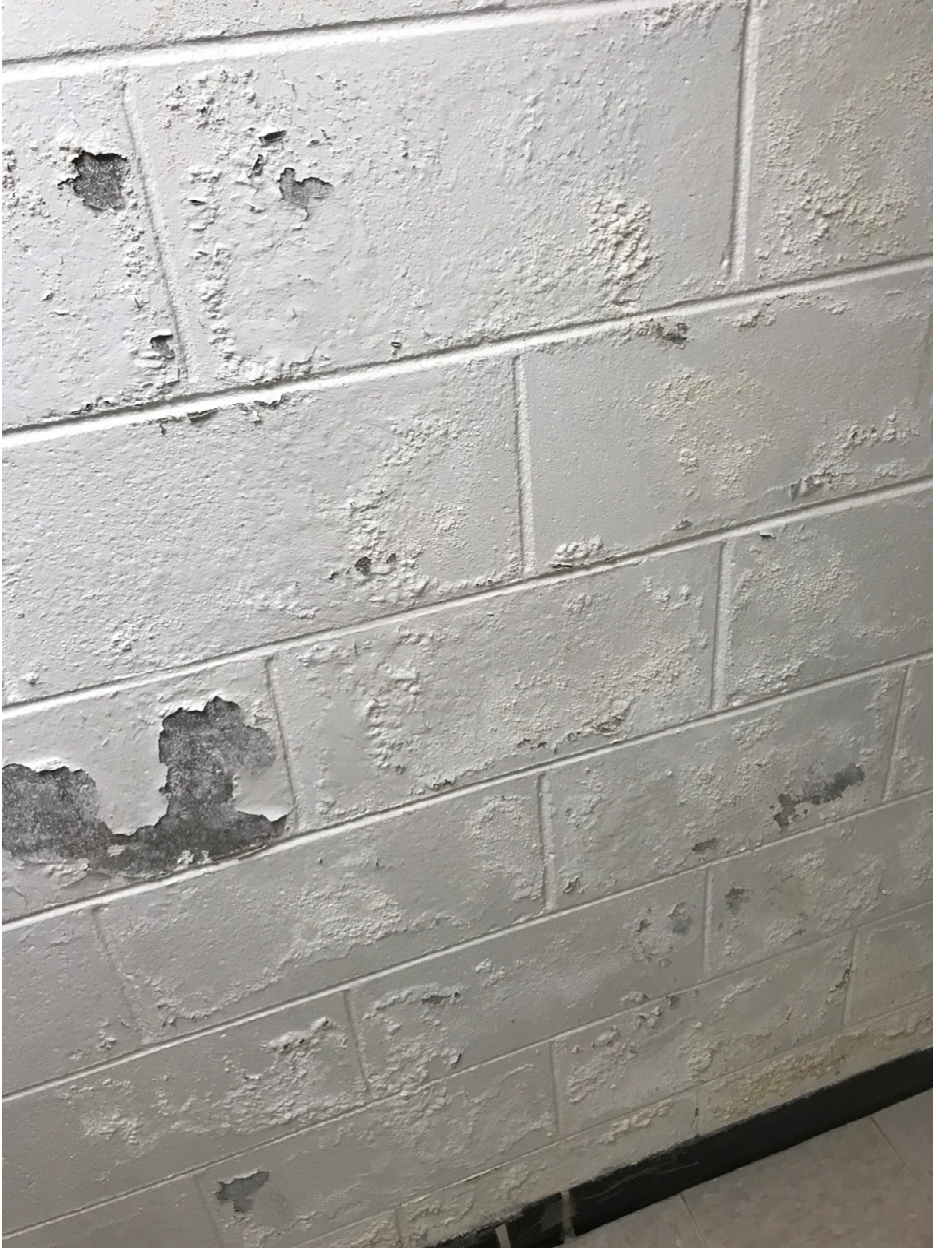
Picture #4. Water intrusion

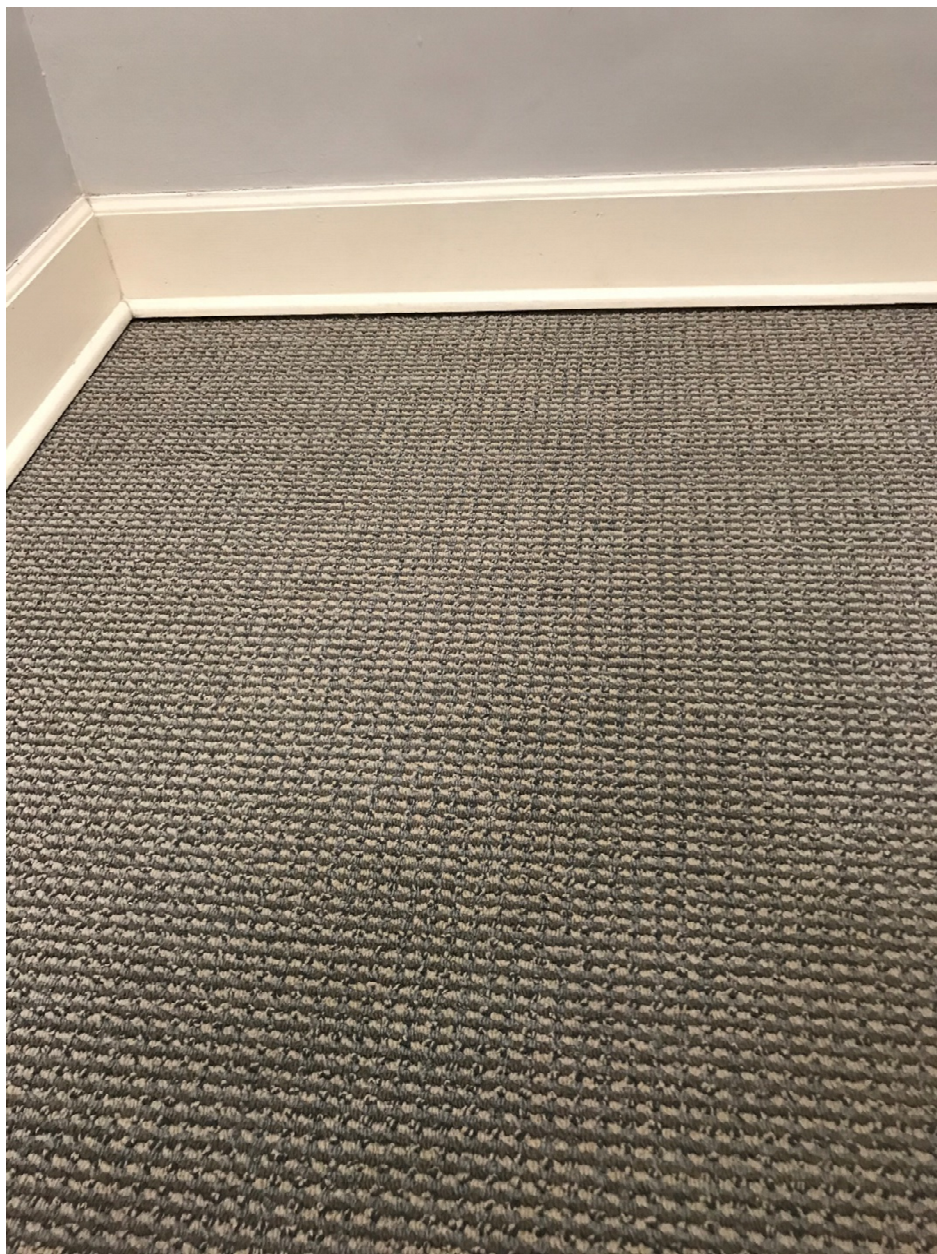
Picture #5. Are where floor appeared to sag

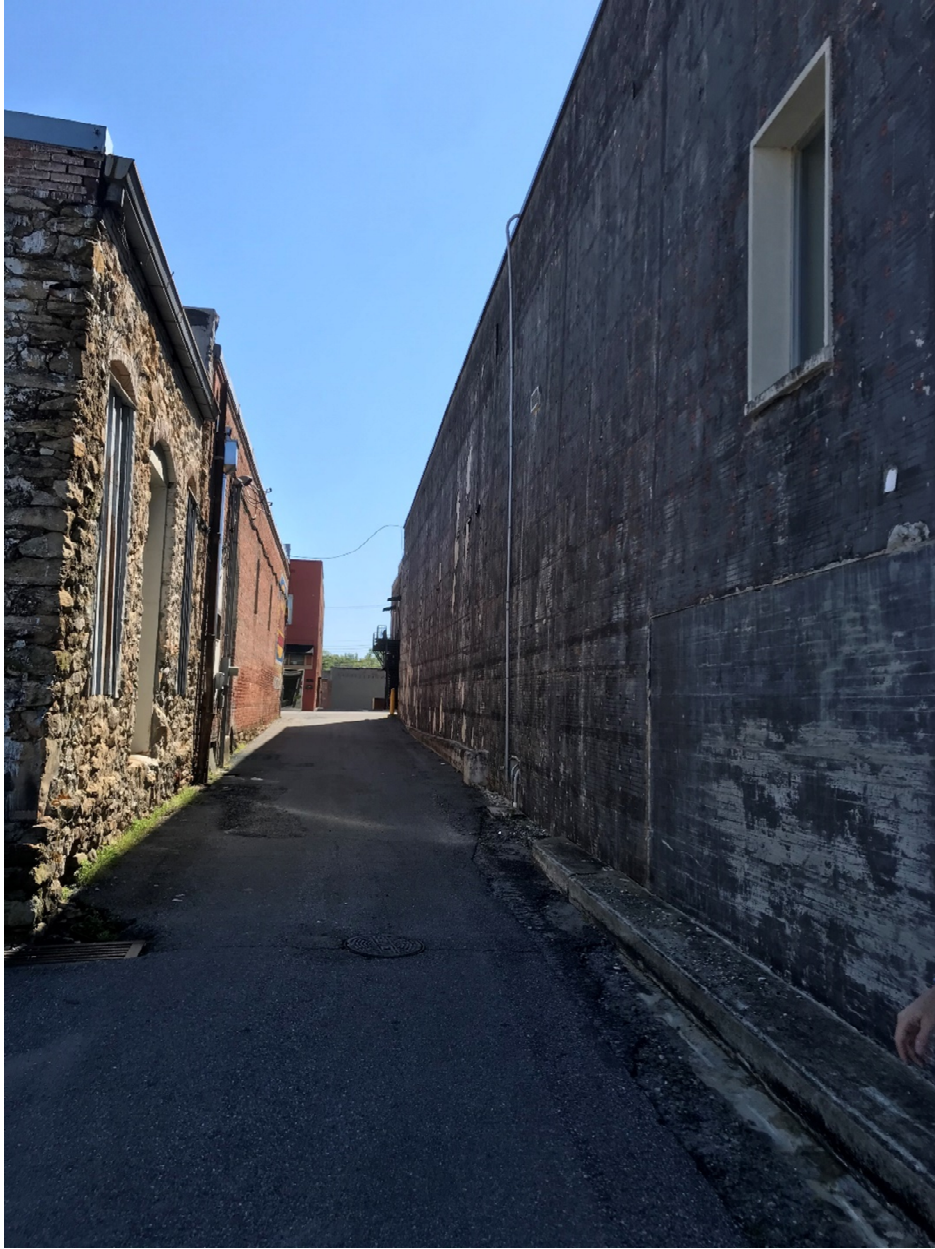
Picture #8. Exterior finish has been removed

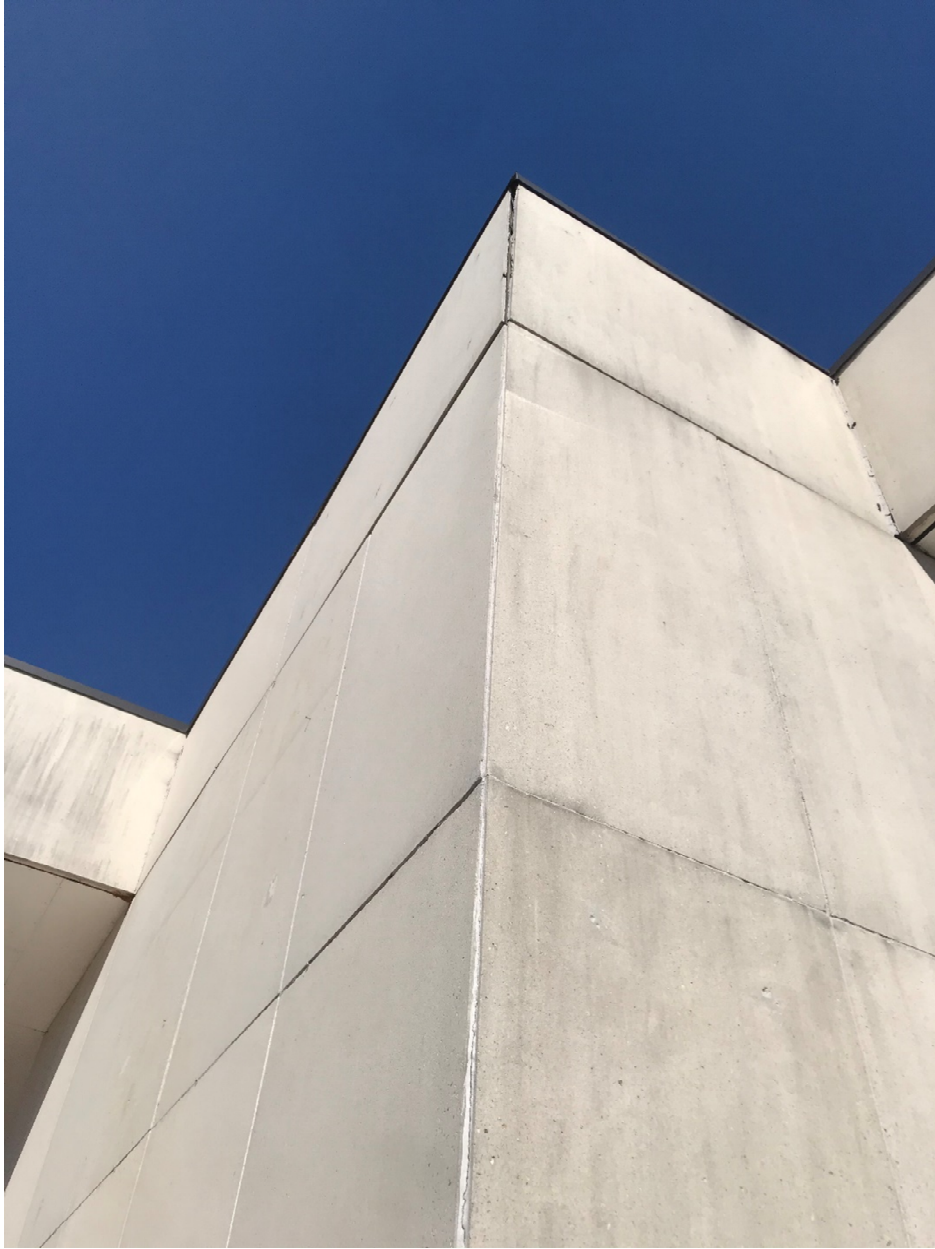
Picture #9. Precast attachment appear to be failing

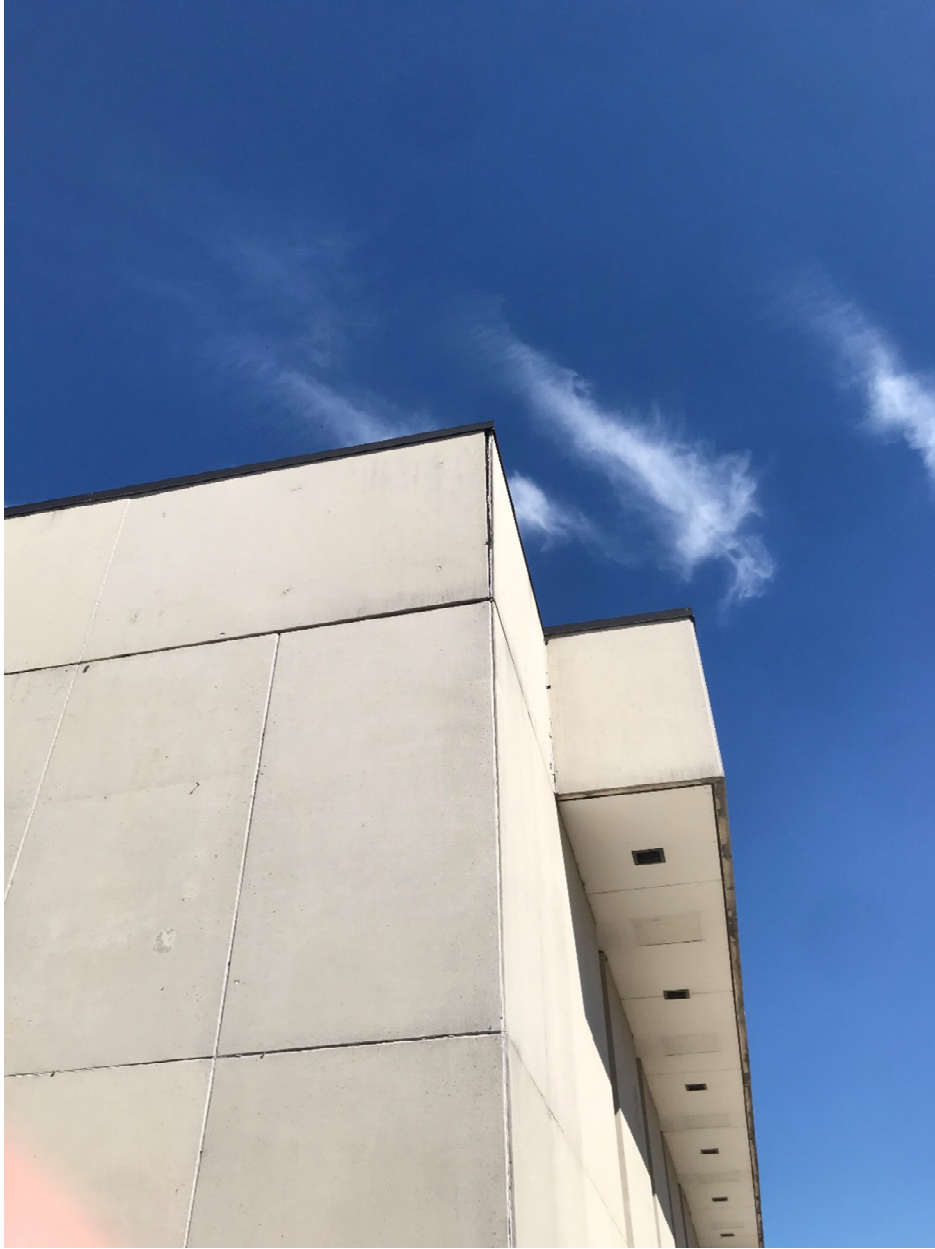
Picture #10. Precast pulling away from building

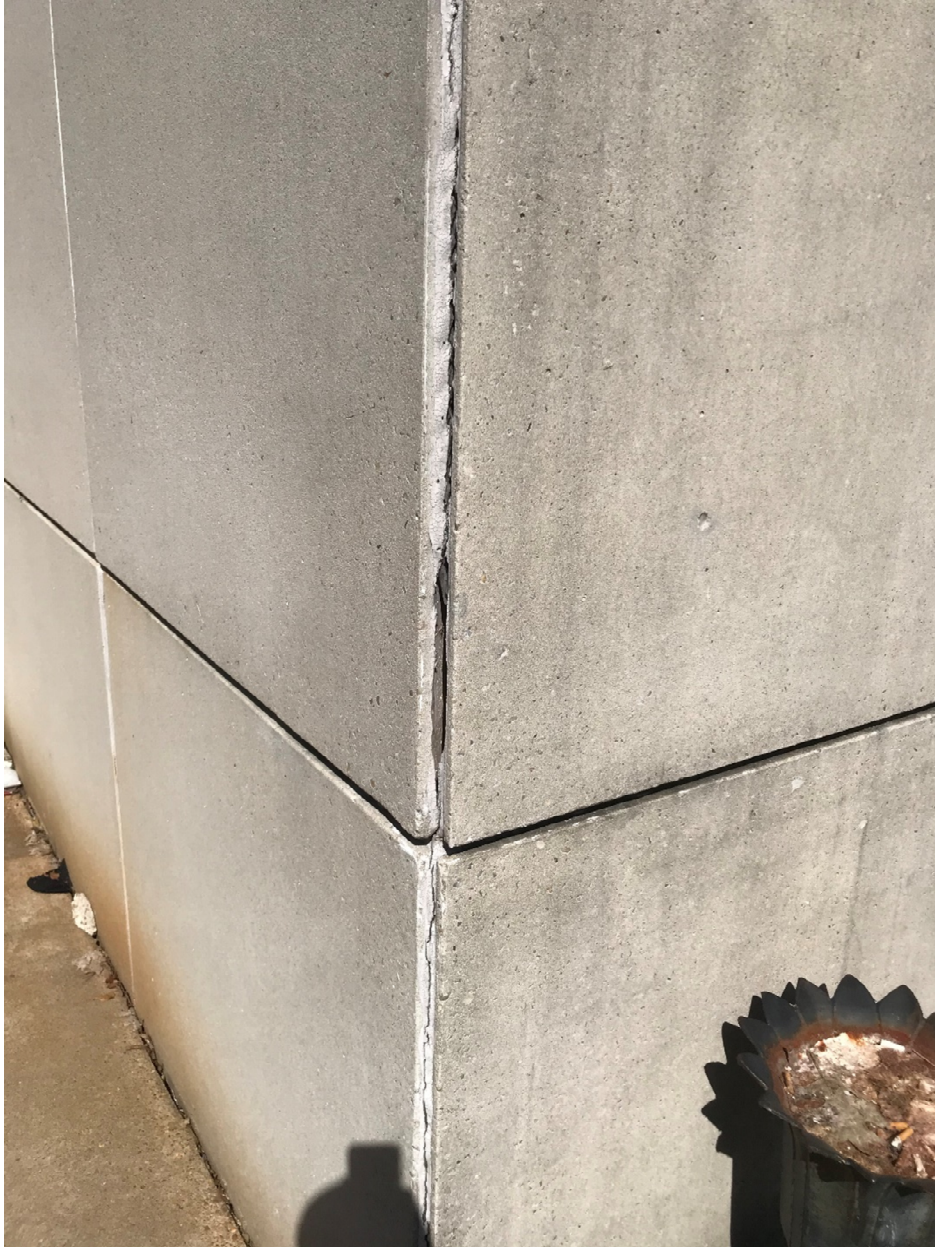
Picture #11. Precast joints appear to be failing

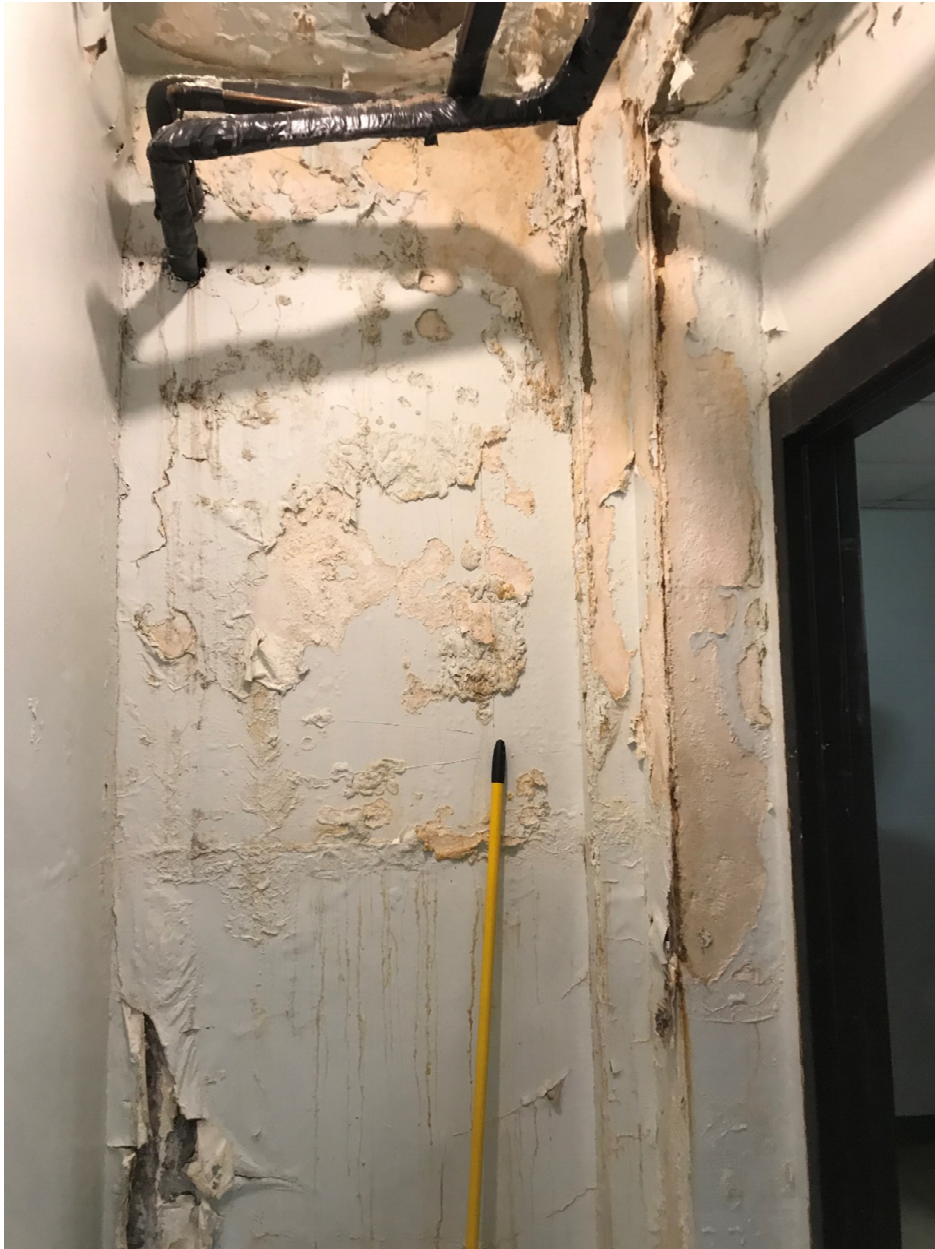
Picture #12. Water intrusion at police department

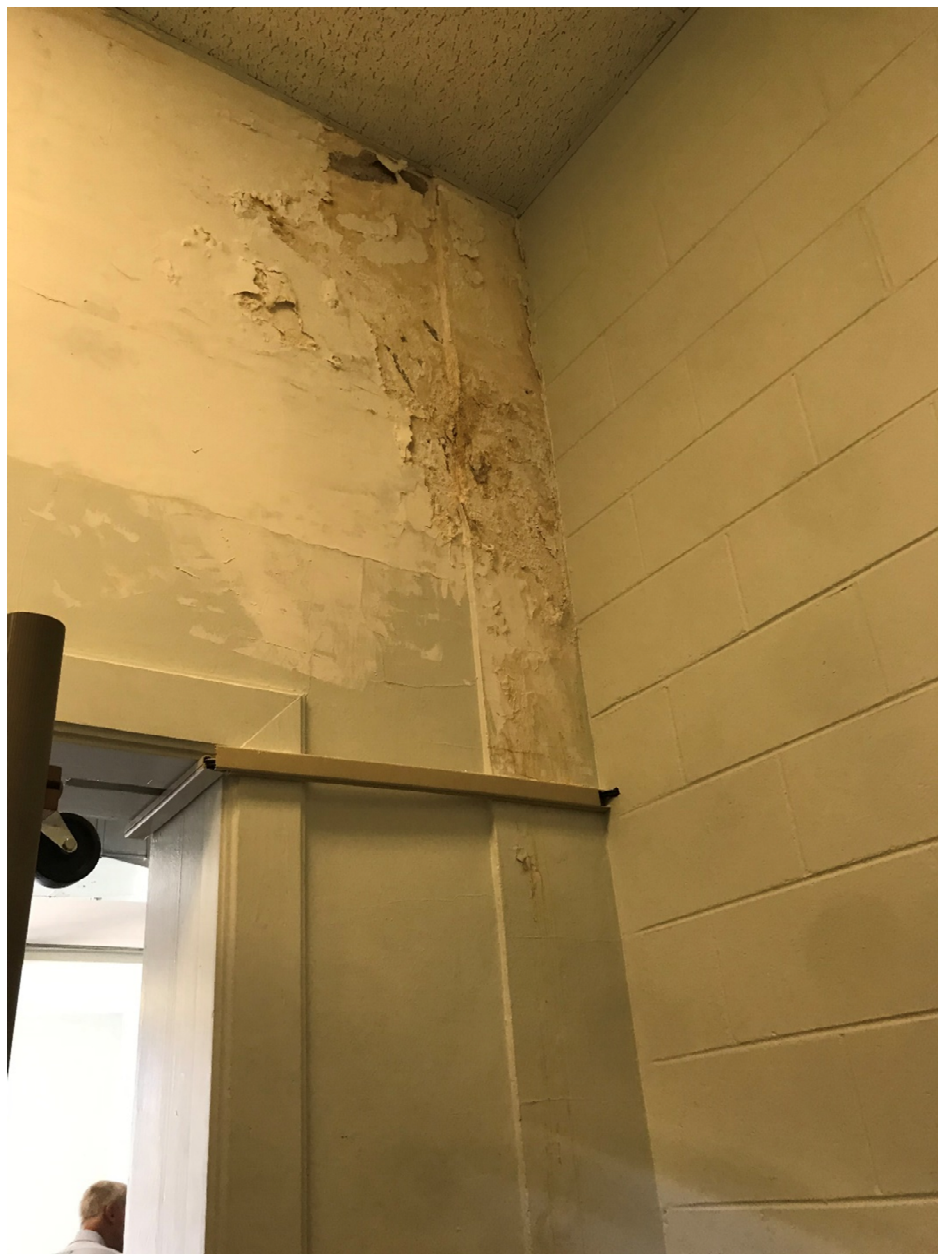
Picture #13. Water damage

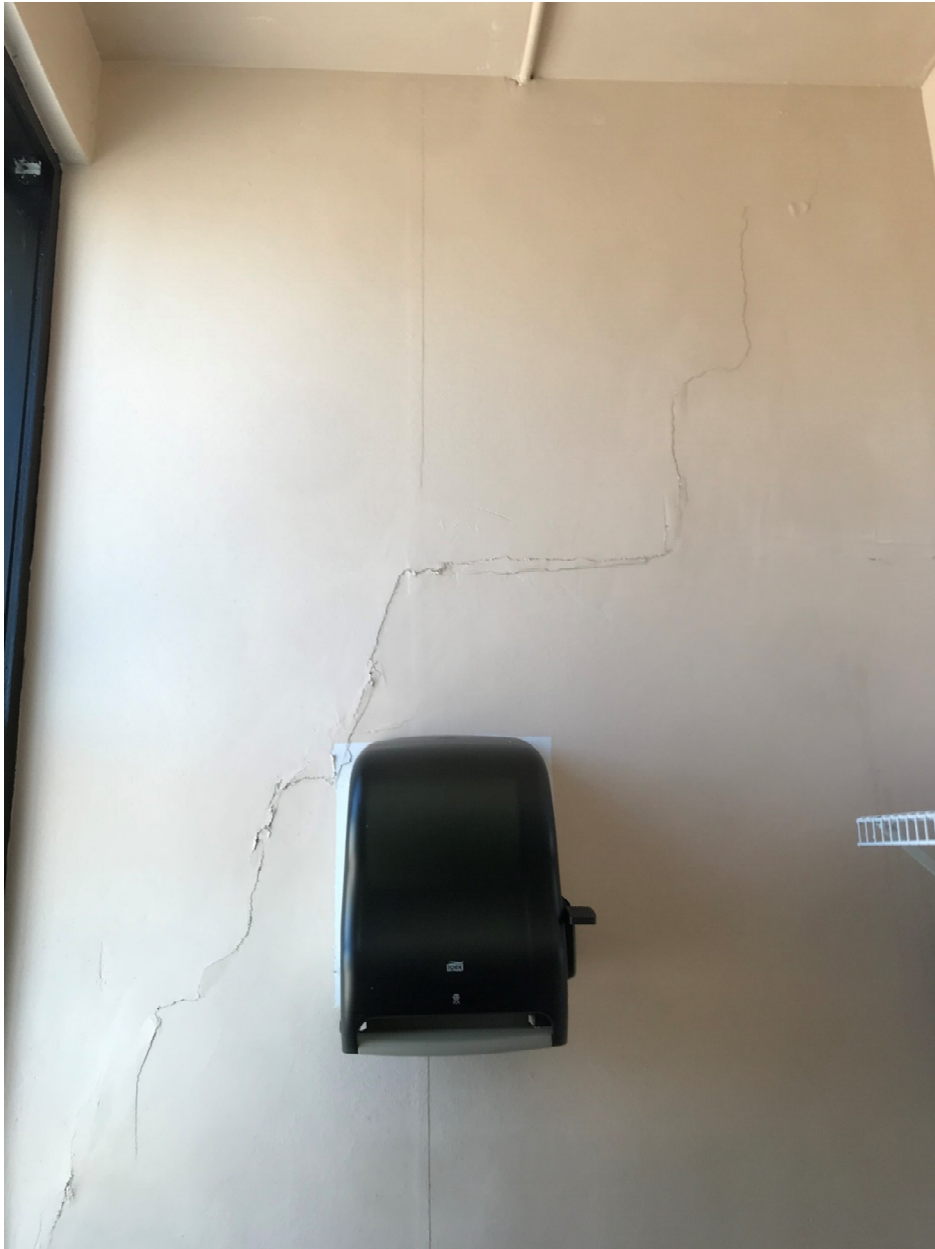
Picture #14. Crack in interior finish

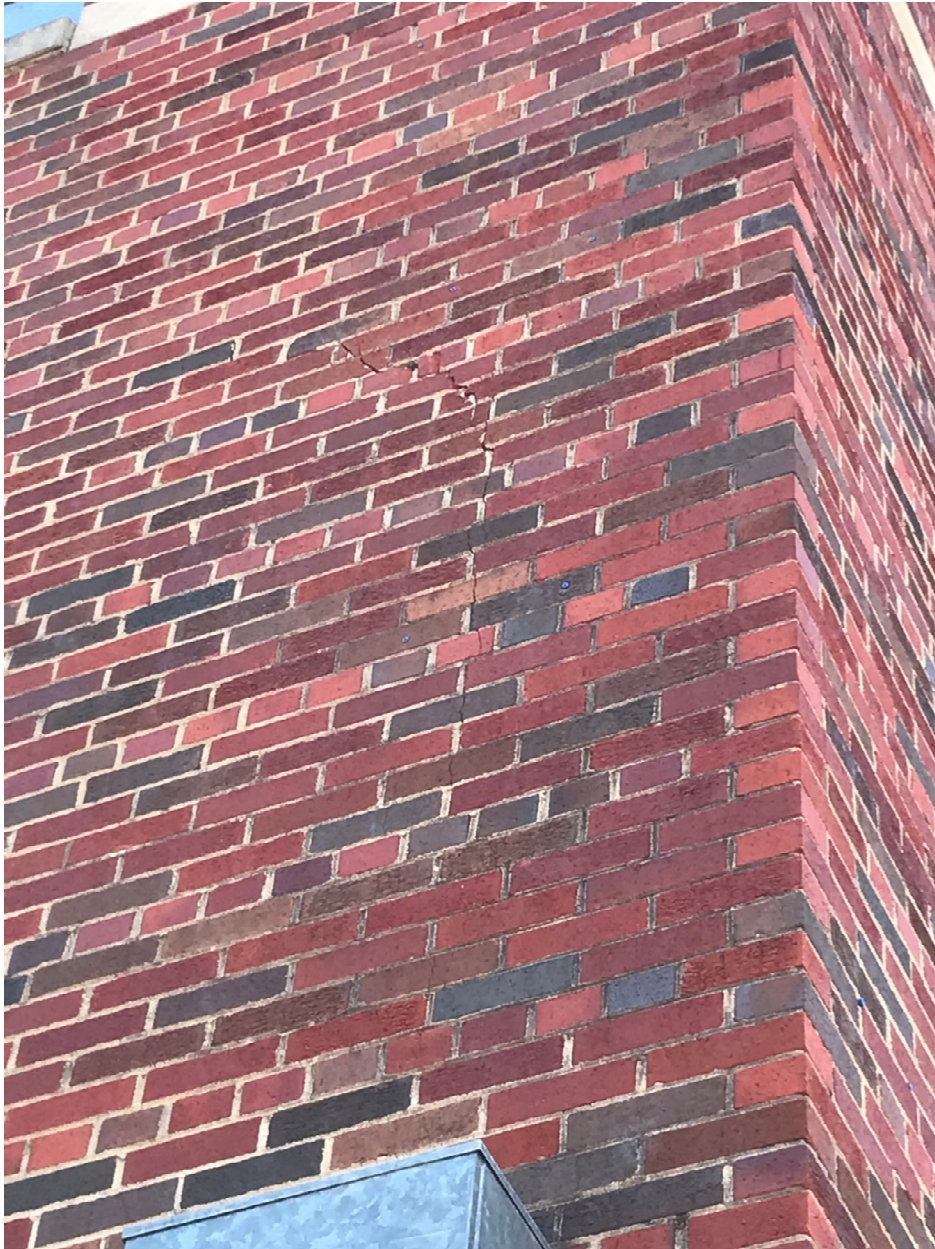
Picture #16. Crack in exterior brick
