BUILDING ANALYSIS OF

ALEXANDER CITY POLICE DEPARTMENT AND CITY HALL

**ALEXANDER
CITY**
ALABAMA

June 17, 2019

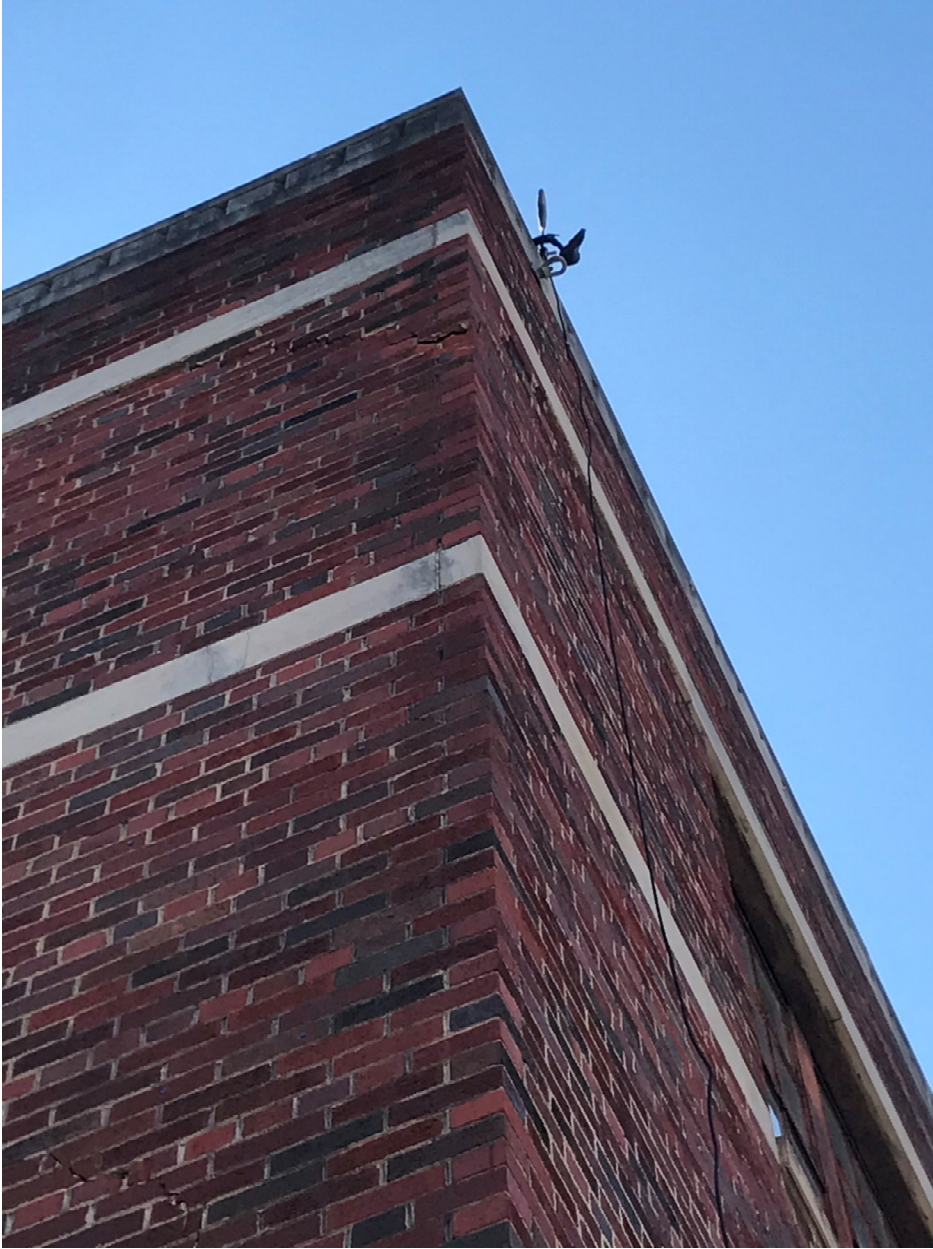
Picture #17. Crack in the exterior brick
