## CITY HALL BUILDING

### **GENERAL DESCRIPTION**

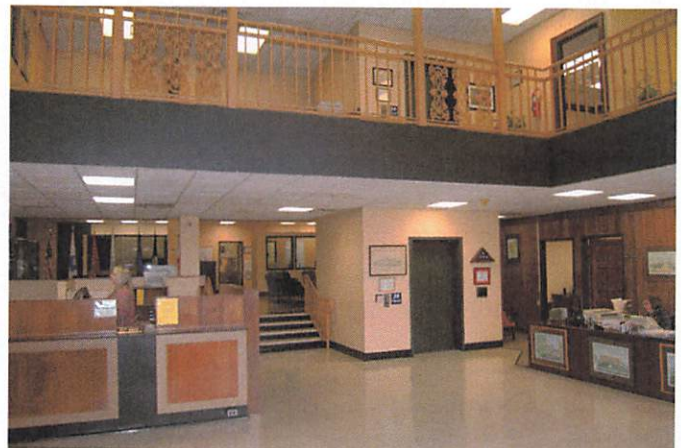
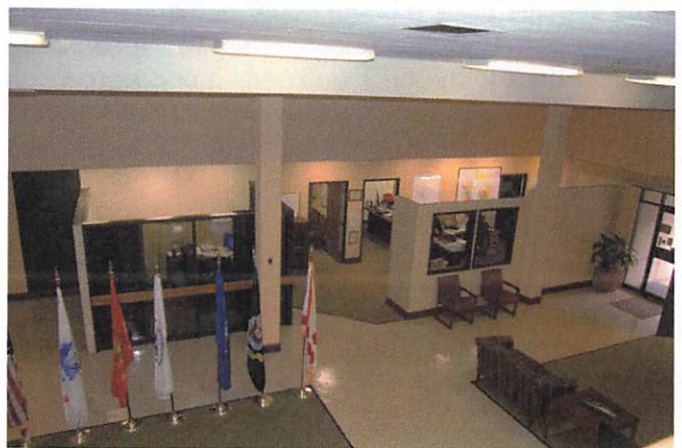
The interior walls are a mix of drywall, paneling, and concrete masonry. Flooring is mostly resilient tile and carpet. The resilient tile is an area of concern mentioned in the Hazardous/Regulated Materials Report (see Appendix). Ceilings are mostly acoustical lay-in tiles in suspended metal grid with some areas of drywall. The finishes are in overall good shape, but dated.

*Current Interior Finishes*

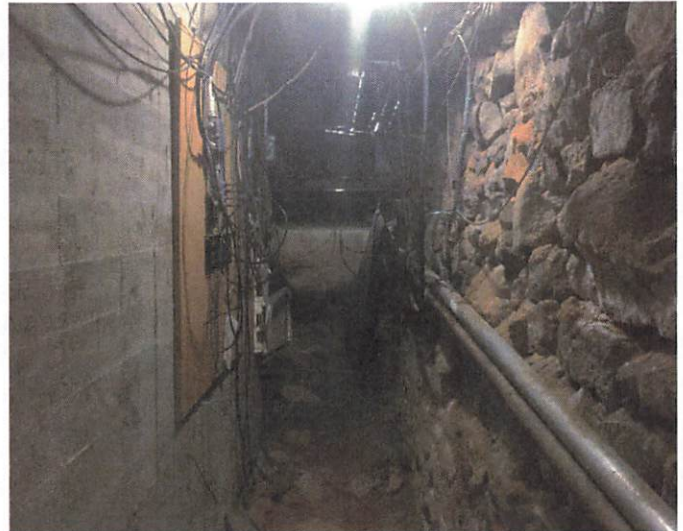
There is a lower level about half of a story (approximately 42") below the main first floor on the west side of the building. The old drive-through teller is located here and houses the sprinkler riser. This lower level includes mechanical, electrical and telephone rooms. Access to the partial basement is from this area down a set of steps with an elevation change of approximately 42 inches. The basement is a storage space and houses the hydraulic elevator equipment and an old vault. It connects to a crawl space that is under the north and east sides of the building. Some of the foundation walls in this area are old masonry walls of uncut stone.

*Stone Walls in Crawlspace*
